## Research Article

# Formation Mechanism and Stability Analysis of the Hejia Landslide

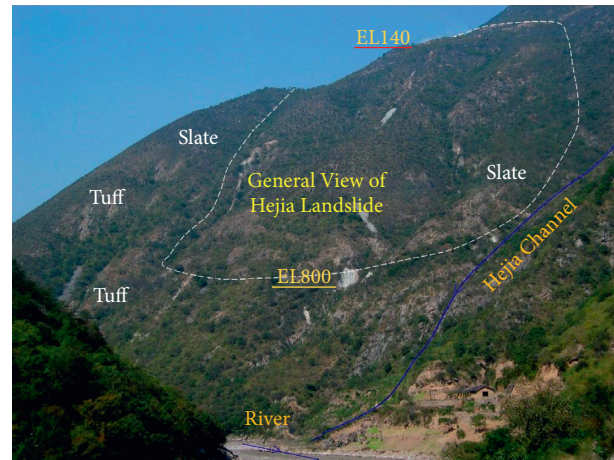
FIGURE 1: General view of the Hejia landslide.

**2.1. Topography of the Landslide.** The hydropower station is located in a canyon area of western China, where landslides and deformation bodies extremely develop. The largest landslide is situated on the left bank, approximately 600 m upstream of the dam site. It can be categorized as a super large landslide as its longitudinal length is 80~900 m and its horizontal width is 360~400 m. The diamond-shaped landslide has an area of 0.34 km<sup>2</sup>, with average thickness longer than 57 m and a volume of  $2,350 \times 10^4$  m<sup>3</sup>. The slope was gentle in the upper part and steep in the lower part, with angles of 24~30° in the upper, 34° in the middle, and 41° in the lower. There are two gullies developed in the sliding mass without cutting through it. They are 550~600 m long, 20~40 m deep, and 2~6 m wide at the bottom. The leading edge, with an elevation of 800~810 m, was 90~100 m above the river level; the trailing edge, with an elevation of 1,450 m, had an obvious 200 m high triangular rupture wall, as shown in Figure 1.

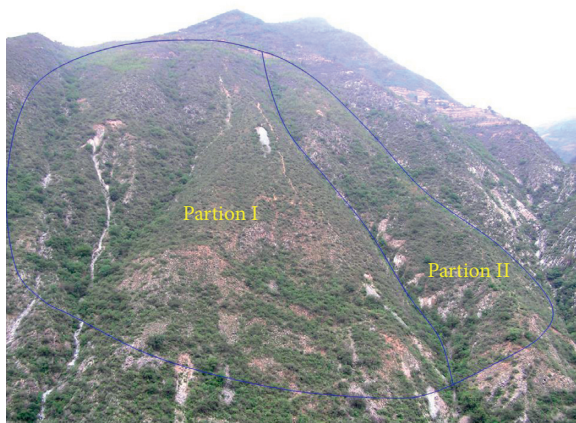
FIGURE 3: Partition map of the Hejia landslide.

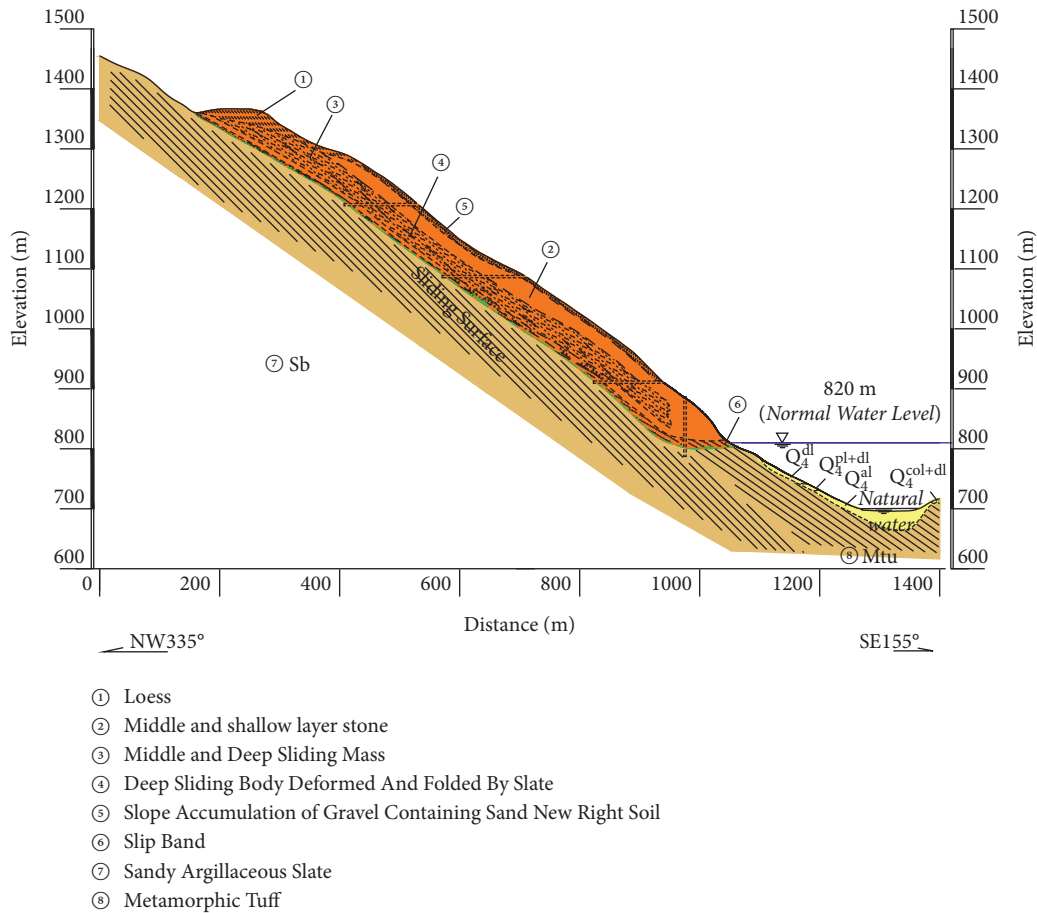
FIGURE 4: Typical geological profile of the Hejia landslide.

**2.2.3. Internal Structure of the Sliding Mass.** Figure 4 is the typical geological profile of the Hejia landslide. The sliding mass can be categorized into 6 zones based on differences in composition.

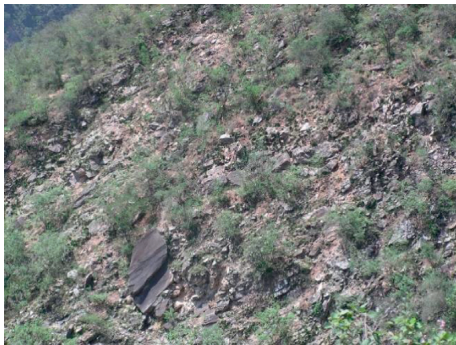
FIGURE 5: Gravel and rock retaining the sequence structure of primary rock in partition I at 960~1,200 m.

mainly distributed in the shallow surface of the sliding mass below 1,200 m elevation. It is composed of gravel and rock formed by the landslide. The zone at the middle part of the sliding mass is the most deformed. Although the patent rock, metamorphic tuff, and arenaceous argillite have decomposed into gravel and rock, the sequence structure of primary rock is still visible (Figure 5). The zone at the front

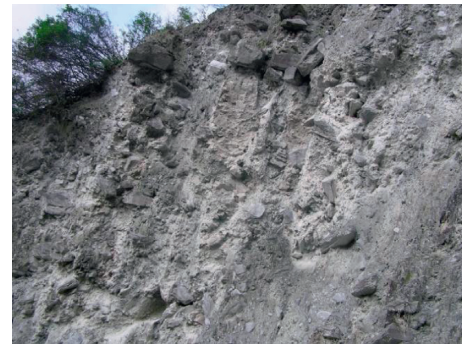
FIGURE 6: Composition of the front of the sliding mass in partition I.

part of the sliding mass consists mainly of badly decomposed primary rock, with much narrow diameters of 0.3~1 m and more fine grain materials can be found (Figure 6).

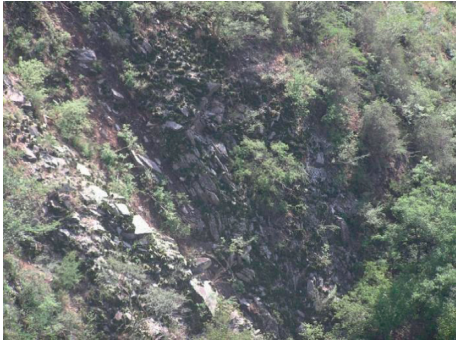
FIGURE 7: Material composition of the sliding mass in partition II.

The lateral gullies of the partition II cut deep inside the sliding mass. Some of the gullies even cut through the sliding mass. The materials exposed on the gully bank are layered metamorphic tuff and arenaceous argillite. Their size depends on the thickness of the single layer of the parent rock. These rocks accumulate and are supported on stilts. Compared with the occurrence of the bedrock, the layered rock in the partition II has changed more. The change was caused by landslide movement. When the landslide occurred, rocks cut by the bedding plane and the structural plane in the sliding mass had uncoordinated displacement, so they separated or squeezed each other. As a result, the occurrence of layered rock in the partition II changed more (Figure 7).

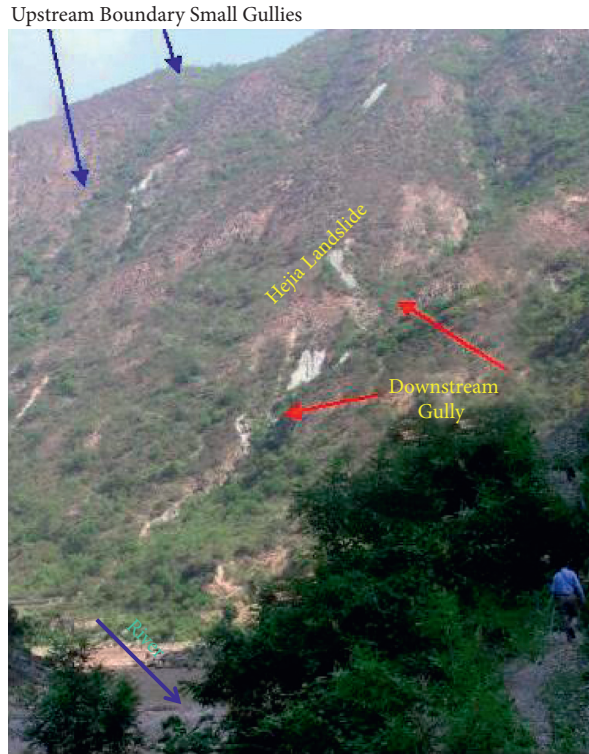
FIGURE 8: Downstream gully and downstream boundary of the Hejia landslide.

developed along the argillite or interbedded compressed zone in the layered rock mass. Figure 8 shows that these large gullies served as the downstream boundary of the Hejia landslide, forming conditions of downstream part being laterally separated from the slope. The upstream boundary of the landslide was comprised mainly of metamorphic tuff, with small gullies, thus having insufficient critical conditions. Moreover, away from the downstream boundary, there was a ridge stretching along the inclined direction of the rock layer. The ridge might block the slide and the large gullies in the lower right of the landslide (downstream boundary) provided conditions for a slight change of direction of the landslide displacement when the slide was blocked.

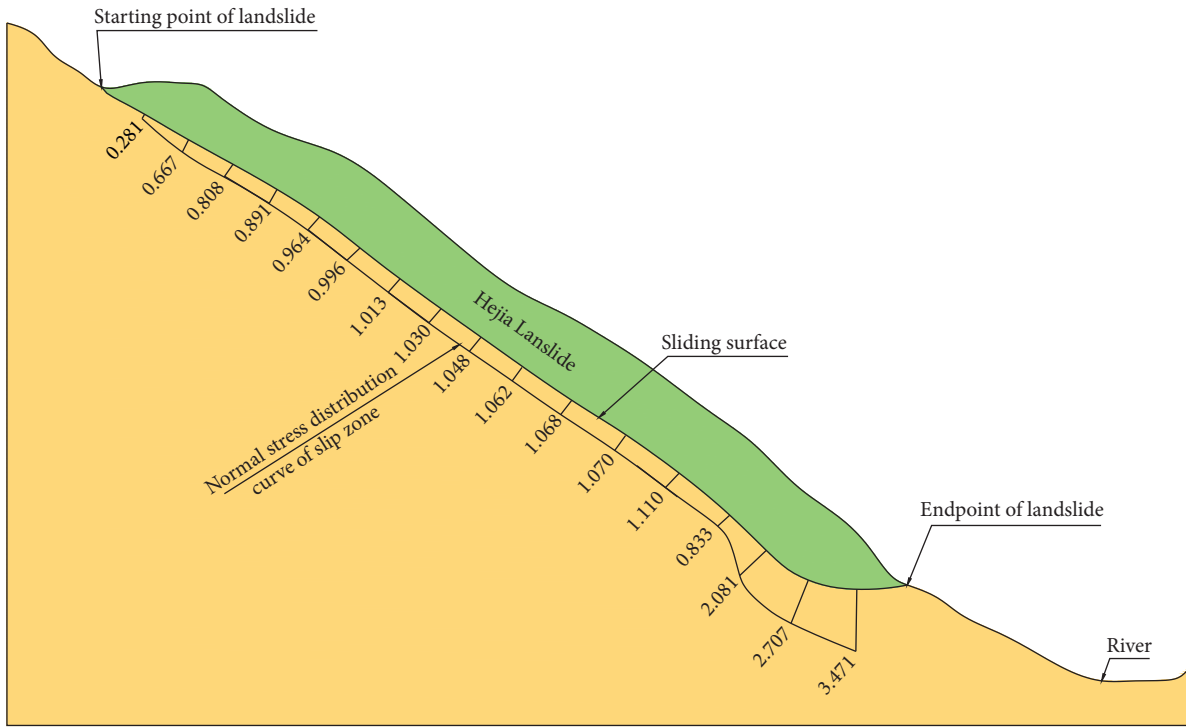
FIGURE 9: Calculation results of normal stress in slip zone of Hejia landslide.

By using element method, formula (1) of the normal stress caused by the dead weight of the sliding body on the sliding surface can be calculated. The normal stress obtained in different sections of the sliding surface is shown in Figure 9. It is shown that the normal stress in the sliding zone of Hejia landslide is relatively small in the upper part and gradually increases in the middle part, and the maximum normal stress in the lower part can reach 3.4–3.6 MPa under the action of the dead weight of the overlying sliding body.

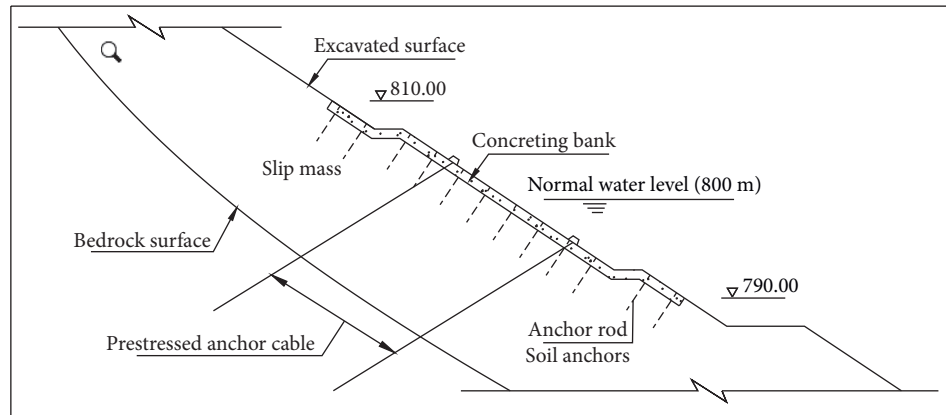
FIGURE 10: Schematic diagram of water level protection zone.

*6.1. Protection of the Water Level Fluctuation Area.* The schematic diagram of water level protection zone is shown in Figure 10. To ensure the stability of the Hejia landslide and prevent instability after bank collapse, the following measures were taken for the water level fluctuation area:

- (1) Range of protection elevation: EL790 ~ EL810.
- (2) The slope and walkway within EL790~EL810 were poured with concrete with a thickness of 80~30 cm and a grade of C20. Then the surfaces were laid with reinforcing meshes with a diameter of 18 mm and a spacing of 25 cm.

- (3) The gravel soil slope within EL790~EL810 was laid with anchor rods with 28 mm diameter, 2 m spacing, and 4.5 m length, and 50 cm of the rod was exposed; the debris slope was installed with soil nails which were 48 mm in diameter and 18 m in length, and 50 cm was exposed.

- (4) The slope was laid with PVC drainage pipes with a diameter of 50 mm and a spacing of 2 m, which extended into the slope and were wrapped with geotextile.

- (5) Besides concrete and soil nails applied for the surface gravel soil in the shallow part, a row of 1,000 KN unbonded prestressed anchor cables, with a length of 30~40 m, a spacing of 6 m, and a depth of entering rock of not less than 5 m, were laid at EL795 and EL800 to ensure the overall stability.
