# Analysis on the Failure Causes of the Collapsed Tubing in an Oil Well

Due to the influence of multiple factors such as internal and external formation and mechanical pressure, medium corrosion and construction operation environment, a tubing collapse failure occurred in an oil well. In order to determine the failure cause of the tubing, physical and chemical tests and mechanical properties analysis were carried out on the failed tubing sample and the intact tubing. The results show that the chemical composition, ultrasonic and magnetic particle inspection, metallographic test, Charpy impact energy and external pressure mechanical property test of the failed tubing all meet the requirements of API Spec 5CT-2021 standard, but the yield strength of the failed tubing does not meet the requirements of API Spec 5CT-2021 standard. Through the analysis of the working conditions, it can be seen that the anti-extrusion strength of the tubing collapse does not meet the API 5C3 anti-extrusion strength standard. The failure type of the well tubing is tubing collapse caused by large internal and external pressure difference.

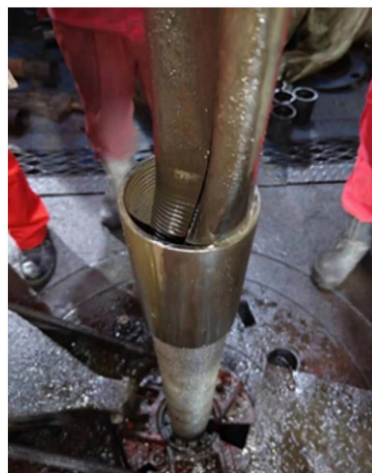
The drilling depth of an oil well is 6750 m, and the lining pipe body is TP110SS type oil pipe. The type of oil pipe is  $\Phi 88.90 \times 12.90$  mm. The depth at which the tubing string collapse occurred is 4252.33 m, and the morphology of the tubing body flattening deformation is shown in **Figure 1**.

Figure 1. Crushed tubing in an oil well.

The physical and chemical properties of the failed tubing body and the intact tubing were tested and analyzed. The results showed that the failed tubing body was TP110SS tubing, and the chemical composition, ultrasonic magnetic particle inspection and metallographic test of the material met the requirements of API Spec 5CT-2021 standard. During the mechanical property test of the failed tubing, the yield strength of one sample in the tensile mechanical test is 704 MPa, which is lower than the standard value of 758 MPa, and the remaining mechanical property test results meet the requirements of API Spec 5CT-2021 standard.

When operating the CPV valve, the maximum pressure difference between the inside and outside of the tube is 88.5 MPa; according to the calculation formula of API 5C3 anti-extrusion strength, after the packer is set up, the anti-extrusion strength of the string collapse (4252.33 m) is reduced from 93.3 MPa to 84.69 MPa, which is less than the external pressure of 88.5 MPa, and there is a

risk of collapse. By calculating the three-axis safety factor of the string during the operation of the CPV valve, it can be seen that the minimum safety factor of the string is 0.966, located at 3374 m; the safety factor of the tubing collapse is 0.997, and there is a risk of collapse.

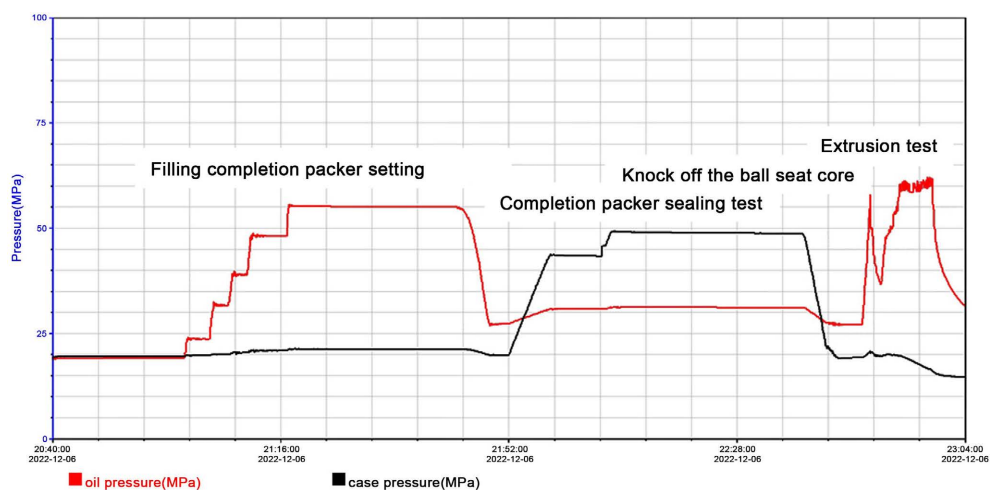
The tubing of an oil well has been destroyed, and it has successively carried out complex working conditions such as setting, sealing inspection, acidification construction, drainage, shut-in, operation of CQ-CPV valve, well killing, and string pulling out [9] [10] [11]. In the process of setting and checking, the changes of oil pressure and casing pressure are shown in **Figure 2**. The oil pressure is finally stabilized at 28.47 MPa and the casing pressure is 14.9 MPa. In the process of acidizing construction, the construction curve is shown in **Figure 3**, and the total amount of acidizing fluid injected into the wellbore is 1258.51 m<sup>3</sup>. The maximum pump pressure is 123.7 MPa and the minimum is 102.3 MPa. The highest casing pressure is 45.3 MPa, and the lowest is 41.5 MPa. The maximum displacement is 7.23 m<sup>3</sup>/min, and the minimum is 3.0 m<sup>3</sup>/min.

Figure 2. The change of oil pressure and casing pressure in the process of setting and sealing test.

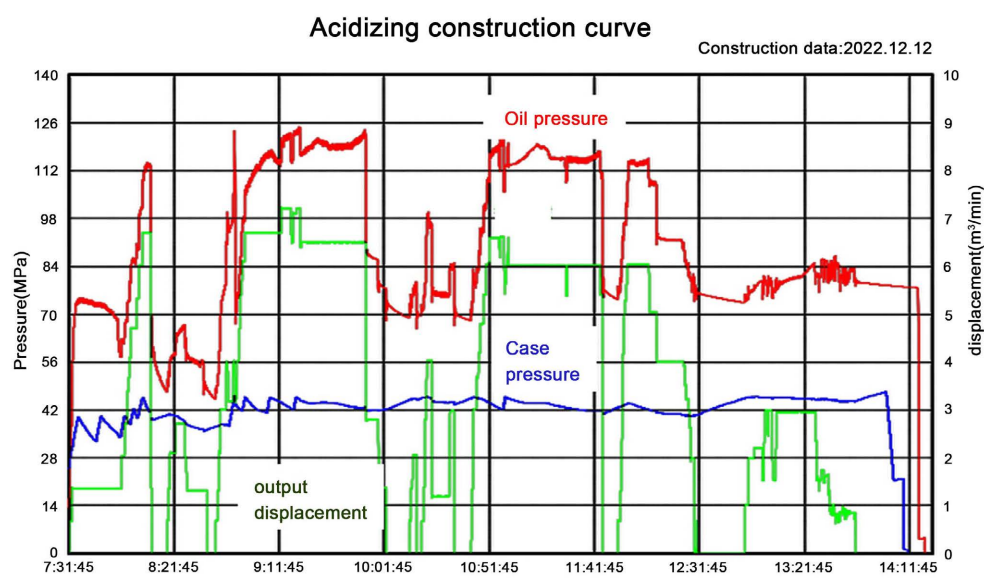
Figure 3. Acidizing construction curve.

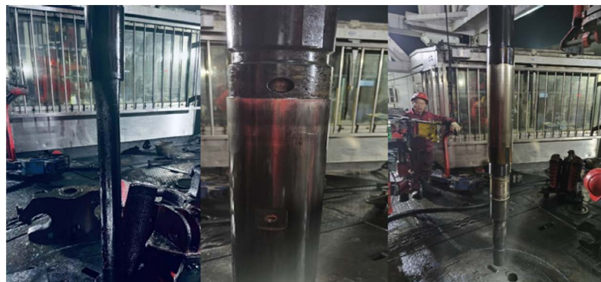
was qualified and the wellbore drainage pressure test was carried out. There was no abnormality in the open well observation outlet. The string is pulled out as shown in **Figure 4**. From the 444th root of the tubing, it is found that the tubing body is flattened and deformed, corresponding to a depth of 4252.33 m. The RD valve rupture disc is not broken, and the circulation hole is normal. The CQ-CPV valve controller rupture disc is not broken, and the tool is normal.

**Figure 4.** Outlet pipe, RD valve, CQ-CPV valve.

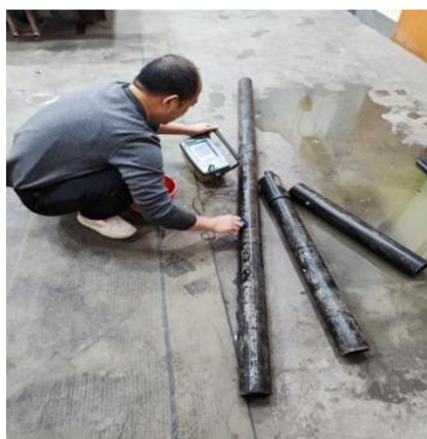
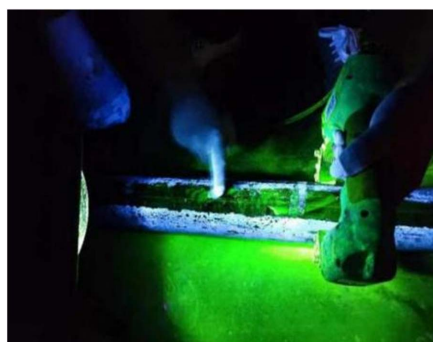
In order to further verify whether there are cracks and excessive defects on the surface of the failed tubing, fluorescent magnetic powder and ultrasonic flaw detection [14] [15] were used to detect the collapsed tubing and the intact tubing respectively, as shown in **Figure 5**, **Figure 6**. The test results show that cracks and over-standard defects are not found on the surface of the extruded tubing and the intact tubing.

**Figure 5.** Ultrasonic flaw detection.

**Figure 6.** Magnetic particle testing.

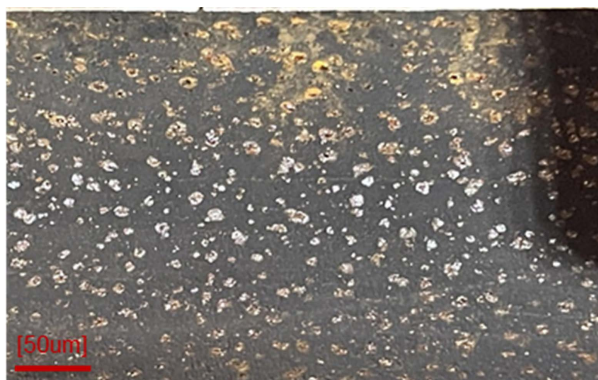
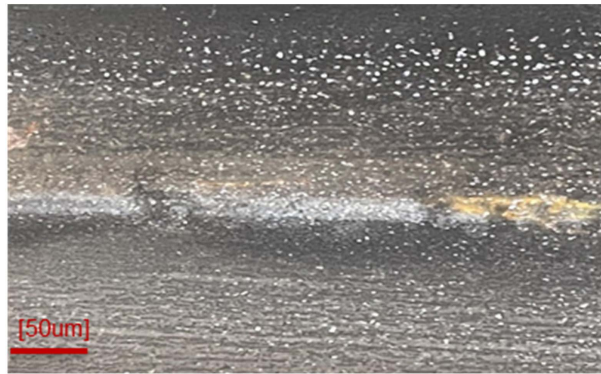
Metallographic examination was carried out on the failed tubing and the intact tubing [16] and the test results were compared. The macroscopic morphology of local corrosion on the inner wall of the tubing was observed. There was local pitting corrosion on the inner surface of half of the inner wall of the intact tubing. There is only less pitting corrosion on the inner wall of the collapsing tubing, as shown in **Figure 7** and **Figure 8**. At the same time, the depth of the corrosion pit was measured, and the corrosion depth of the inner wall was detected by a stereomicroscope. It was found that the spot was higher than the inner wall surface, and the cone was protruding, as shown in **Figure 9**. The analysis shows that the pitting corrosion does not reduce the wall thickness of the tube.

**Figure 7.** Macroscopic morphology of local corrosion on the inner wall of intact tubing.

**Figure 8.** Macroscopic morphology of local corrosion on the inner wall of extruded tubing.

**Figure 9.** Measurement of corrosion pit depth.

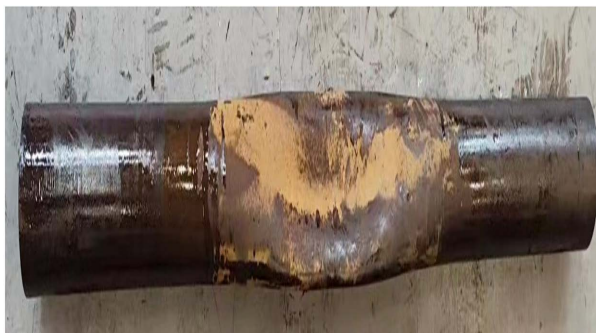
From the test results, it can be seen that when the applied external pressure test value is lower than the minimum guarantee value of 93.3 MPa specified in API 5C2 standard, the intact tubing does not collapse. When the external pressure test value is greater than the minimum guarantee value of 93.3 MPa

specified in API 5C2 standard, the tubing collapse failure occurs, as shown in **Figure 10**.

**Figure 10.** Collapse failure of intact tubing.
