Article

Shear Mechanical Properties of Bolt-Grout Interface under Different Bolt Surface Profiles

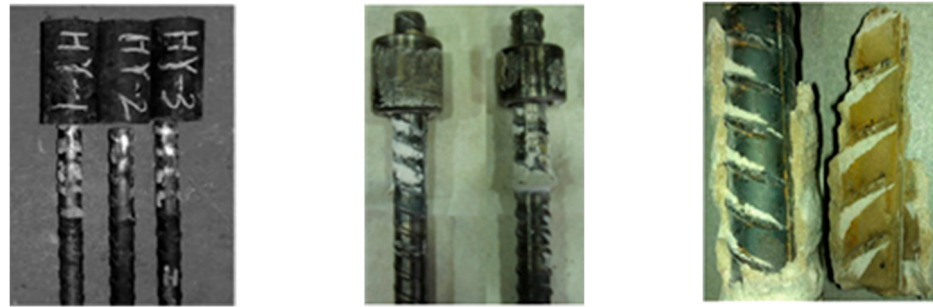
Figure 1. Interface failure of Bolt-Grout in pull-out test [3].

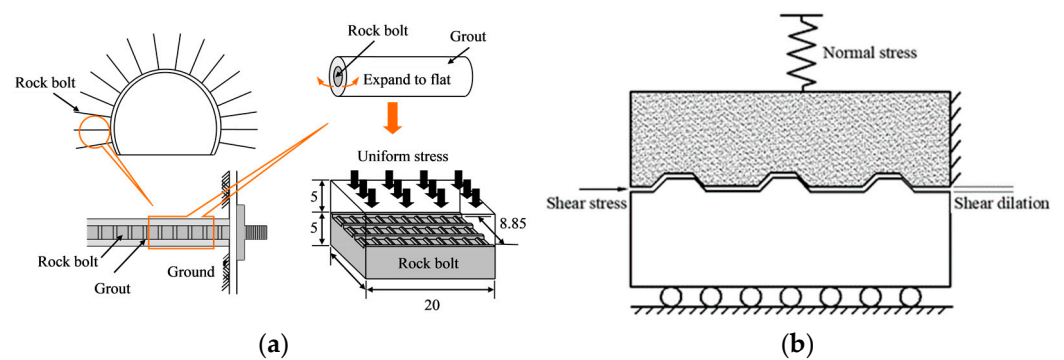
Figure 2. The shear model of Bolt-Grout interface [34]. (a) Schematic diagram of the Bolt-Grout system (unit: mm) [32]. (b) Two-dimensional shear modeling of the Bolt-Grout interface.

The specimen of the Bolt-Grout interface consisted of a steel part and a grout part. Referring to Zhang et al. [15,35,36], the simplified 2D surface profile of the steel plate was used to simulate the bolt rod. The concept and process to make a flat specimen of the grout-rock interface is shown in Figure 2. The lateral boundary conditions of the unfolded surface have been simplified by the bolt’s real force to create a two-dimensional shear model, as seen in Figure 2b.

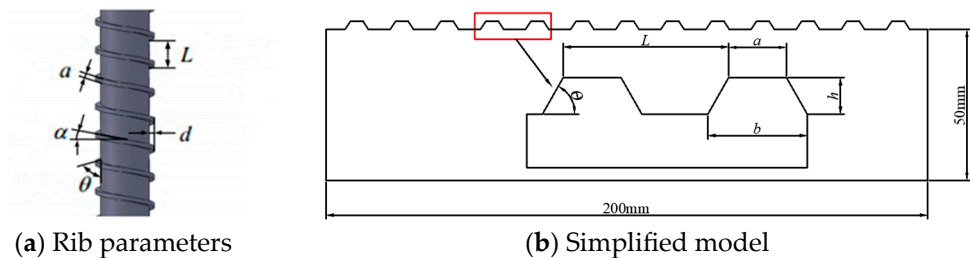
Figure 3. (a) Rib parameters. (b) Simplified model. Parameters of rebar rib and simplified model (The red box in (b) are ribs).

It is especially important to choose the anchor material reasonably in the indoor test. In this paper, the steel used for the preparation of rebar bolts was selected as the bolt unfolding specimen, featuring a specimen size of $L \times W \times H = 200 \text{ mm} \times 100 \text{ mm} \times 50 \text{ mm}$. The main geometrical parameters of the bolt surface profile are the bolt rib spacing L , the rib height h , the rib width a , the rib angle θ , and the angle of thread rise α , shown in Figure 3. In this paper, the rib spacing and angle were selected as the main variables of the test to be investigated, and the rib height h and transverse rib width a of each steel plate specimen were 1.2 mm and 1.9 mm, respectively.

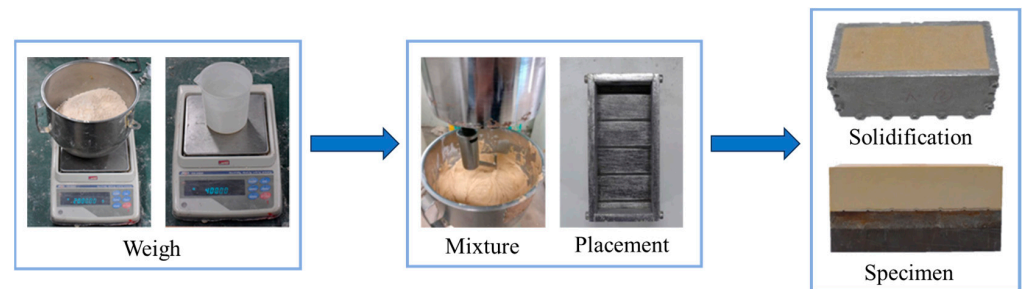
Figure 4. Flow chart of preparation of mortar specimens.

In the preparation of the gypsum specimens, the steel mold was placed in a mold the size of $L \times W \times H = 200 \text{ mm} \times 100 \text{ mm} \times 100 \text{ mm}$. The mold was brushed with mineral oil;

then gypsum and water were mixed according to the mass ratio of 2:1, and stirred well with a mixer; the stirred gypsum slurry was poured into the mold and put on the shocking table for 1 min to exclude the air bubbles. Finally, the excess gypsum slurry was scraped with a scraper to keep the surface of the specimen flat. The plaster reached a certain strength after 30 min of resting, the mold was removed, and the specimen was taken out and cured in the air environment for 7 d to get the molt-grout specimen. Specific process is shown in Figure 4. The physico-mechanical parameters of gypsum are shown in Table 1.

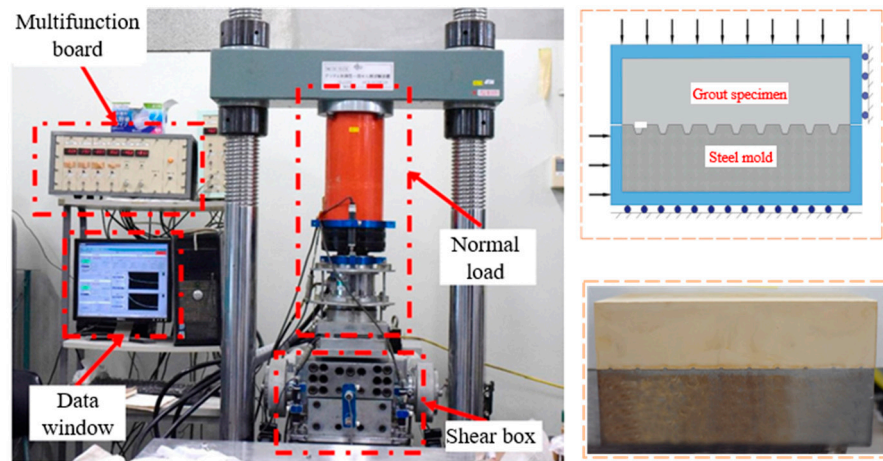
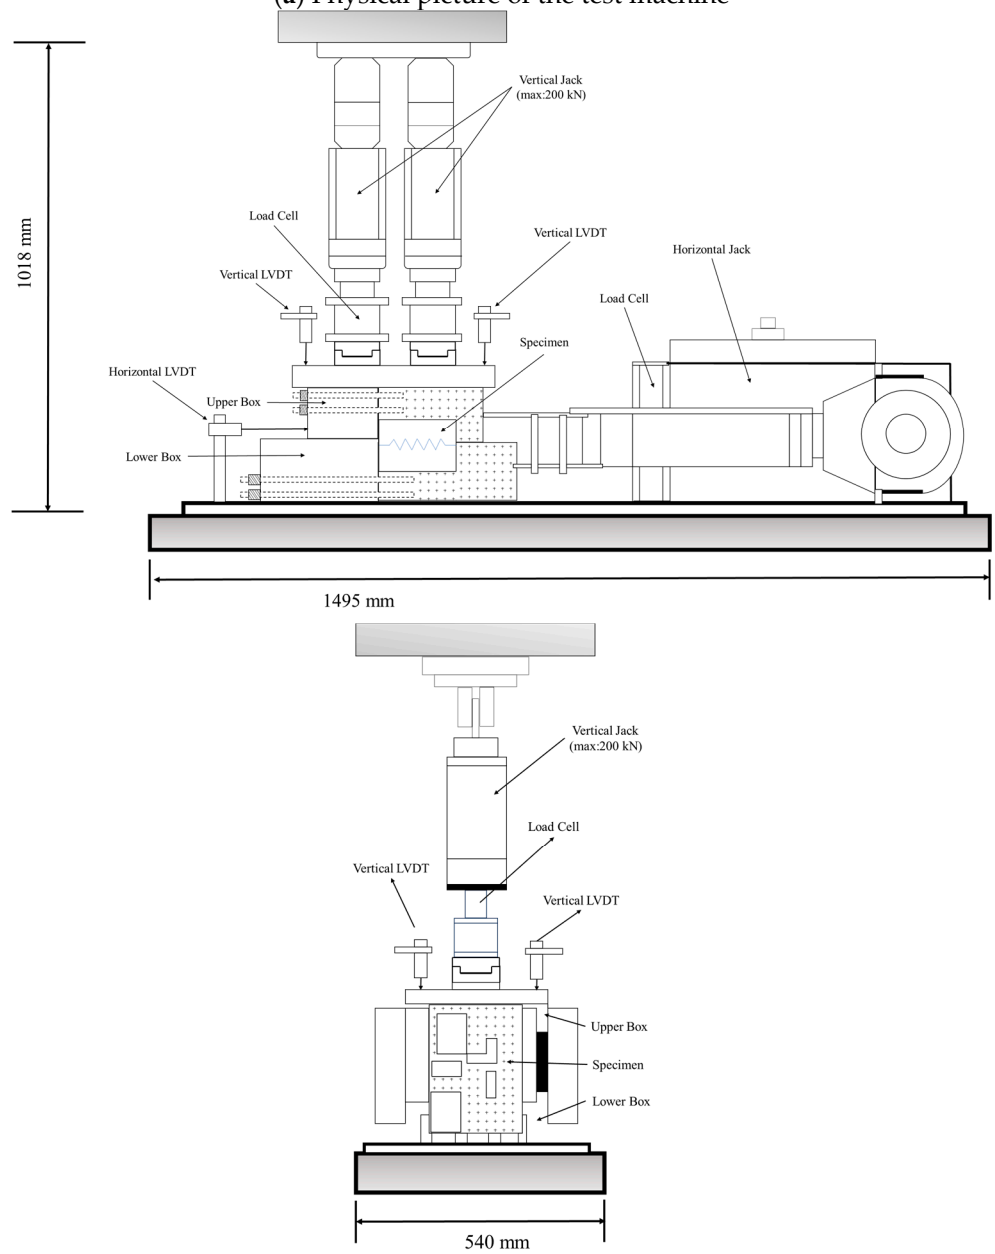
(a) Physical picture of the test machine

(b) Schematic diagram of testing machine

Figure 5. CNC shear testing machine.

Bolt-Grout interfaces were tested in shear using a CNC-type shear test set-up [37,38], which is shown in Figure 5. The apparatus consisted of a loading system, data acquisition and a controlling system. Throughout the test, the top shear box could move in a normal direction but not the shear direction, while the lower box could only move in the shear direction. Controlling the servo-controlled hydraulic pump and the hydraulic cylinders applied the maximum of both the normal and shear forces at 200 kN. Two LVDTs were positioned parallel to the lower shear box's surface to measure the displacement brought on by the shear forces, and four LVDTs were positioned on top of the shear box to measure the normal displacement. The precision of the LVDTs was 0.001 mm, with a range of 0–20 mm.

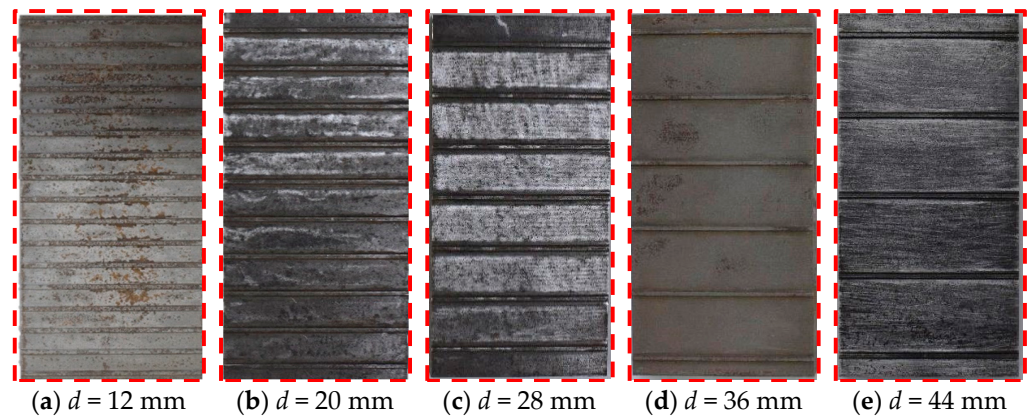
Figure 6. Steel molds with different rib spacings.

This paper has chosen five different rib spacings and five different rib angles based on the surface profiles of bolts that are frequently used in field engineering applications. Shear tests were performed on the specimens, and the effects of the rib spacings and rib angles on the shear characteristics of the Bolt-Grout interface were investigated. Figures 6 and 7 depict the several steel molds with varying rib angles and spacing.

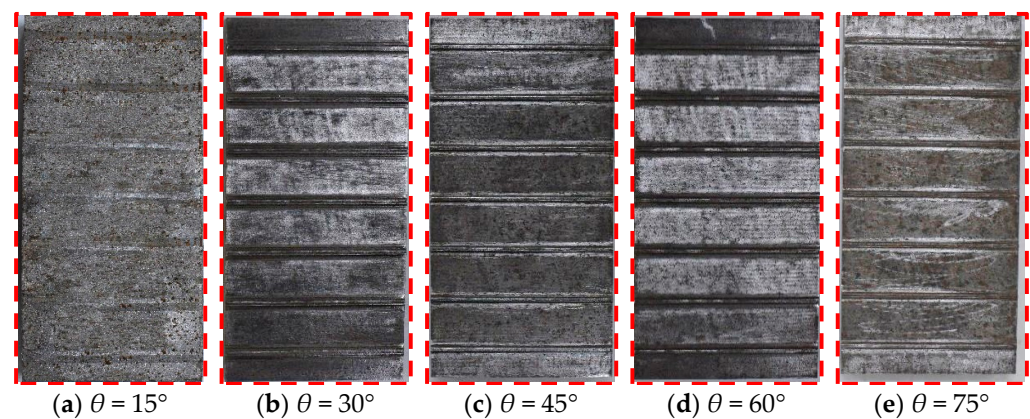
Figure 7. Steel molds with different rib angles.

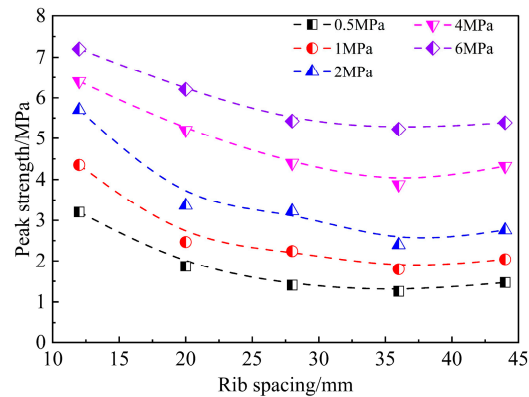
Figure 10 illustrates the variation of peak strength with rib spacing under different normal stresses. The change rule of peak strength is the same, i.e., the increase in rib spacing shows the change trend of decreasing and then increasing. Meanwhile, the smaller the rib spacing, the more obvious the change. For example, when the normal stress was 0.5 MPa, the shear strength decreased by 1.33 MPa and 0.15 MPa when the rib spacing was increased from 12 mm to 20 mm and 28 mm to 36 mm, respectively. The figure also shows that, under all typical stress conditions, the shear strength at 44 mm rib spacing surpasses 36 mm, which is due to the change in the failure mode.

Figure 10. Effect of rib spacing on peak shear strength.

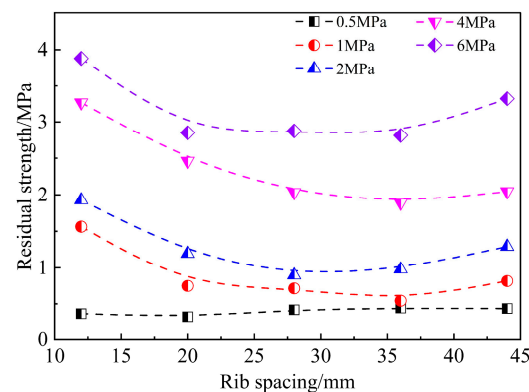
Figure 11 illustrates the variation of residual strength with rib spacing under different normal stresses. As the rib spacing rises, the residual shear strength generally exhibits a trend of dropping and then increasing. It is significant to observe that, at 0.5 MPa, the residual shear strengths for all five rib spacings are comparable. The rib spacing has a minimal effect on the residual shear strength. This is because the residual shear stress is mainly generated by the friction of the interface. The interface friction is weaker at 0.5 MPa, and changing the rib spacing no longer affects the interface friction.

Figure 11. Effect of rib spacing on residual shear strength.

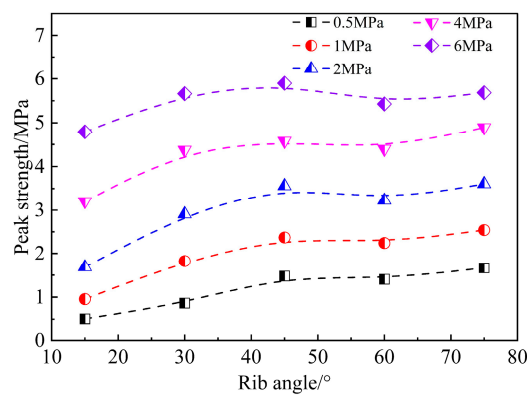
Figure 12 illustrates the variation of peak strength with rib angles under different normal stresses. The pattern of variation is the same for all five normal stress conditions, as

the peak strength exhibits a trend of initially increasing, followed by a decrease, and then subsequently increases with the increase in rib angle. There is a continuous increase in the peak strength from 15° to 45° of the rib angle. However, the growth rate begins to decrease, indicating a diminishing return on increasing the rib angle. Subsequently, when the rib angle is more than 45° to 60°, the peak shear strength begins to decrease. Finally, the peak shear strength begins to recover again as the rib angle continues to increase. The reason is that shear-slip failure mainly occurs when the rib angle is small, with the increase in the rib angle, the protruding part of the gypsum specimen starts to shear-break failure, and the peak shear strength increases; meanwhile, the increasing angle will make the protruding part of the gypsum specimen more easily sheared, and the peak strength decreases; the promotion of shear is no longer evident when the angle reaches a particular magnitude, but the interfacial meshing effect is more significant, and the peak strength goes back up. There exists a relative optimum value for the rib angle, and the greatest value of peak strength can be considered to occur when the rib angle is 45°.

Figure 12. Effect of rib angle on peak shear strength.

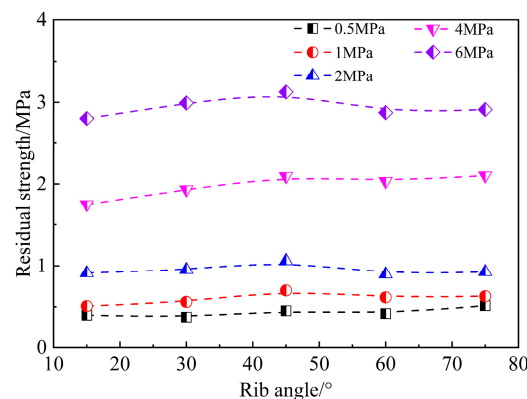
Figure 13 illustrates the variation of residual strength with rib angles under different normal stresses. Compared with the peak strength, the residual strength is less affected by the rib angle, but the rule of change is similar, with the increase in the rib angle, the residual shear strength exhibits a trend of initially increasing, followed by a decrease, and then subsequent increase, when the rib angle of 45°, it can be considered that the residual shear stress appeared to be the maximum value. The reason for this phenomenon is that shear-slip failure occurs when the rib angle is small, and as the rib angle increases, shear-break failure begins to occur; shear-slip produces smaller debris, which is manifested as smaller residual shear stress and shear break-break failure make the bulge failure more serious, and the interface is rougher, with a larger residual shear stress. The effects of normal stresses on peak and residual shear strength for different rib angle conditions are the same as for different rib spacing conditions.

Figure 13. Effect of rib angle on residual shear strength.

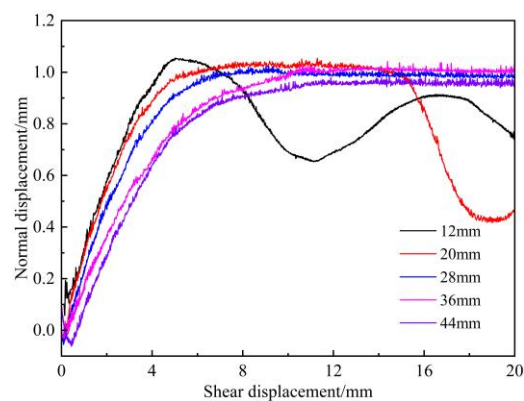
Since the normal displacement curves exhibited a similar trend for specimen under different normal stress conditions, we take the normal stress of 2 MPa as an example to illustrate the shear dilation behavior of Bolt-Grout interface. Figures 14 and 15 illustrate the normal displacement-shear displacement curves for different rib spacings and rib angles under a normal stress of 2 MPa. When the rib spacing is small, such as 12 mm and 20 mm, the normal displacement decreases because the gap at the Bolt-Grout interface is compacted in the early phases; afterward, the normal displacement progressively rises due to the shear dilation; finally, due to the existence of the “climbing effect”, the normal displacement exhibits a cyclical pattern of initial decrease followed by a subsequent increase. For larger rib spacing, such as 28 mm, 36 mm and 44 mm conditions, the trend of normal displacement is approximately the same, and all show a tendency to decrease and then increase before leveling off. The rib spacings have different effects on the normal displacement in the final stage of shear, which is mainly due to the increase in rib spacings, the number of ribs in the interface decreases, so that the “climbing effect” is no longer obvious, and the number of cyclic changes in normal displacement decreases.

Figure 14. Normal displacement-shear displacement curves of Bolt-Grout interface under different rib spacings ($\sigma_n = 2$ MPa).

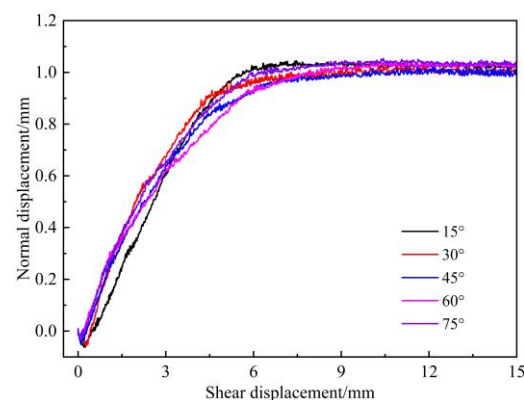
Figure 15. Normal displacement-shear displacement curves of Bolt-Grout interface under different rib angles ($\sigma_n = 2$ MPa).

The normal displacement-shear displacement curves under different rib angle conditions have roughly the same morphology, and the normal displacements show a tendency to decrease and then increase and then level off, as shown in Figure 12. In the early stage of shear, the difference in normal displacement under different rib angle conditions is small, which is because the change in normal displacement at this stage is caused by the compression density and elastic deformation, and the internal cleavage and elastic modulus of each specimen are the same again. As the shear displacement increases, the discrepancy in the

normal displacement among various rib angles becomes more pronounced, the normal displacement was the largest at 15° and the smallest at 30°, and with the increase in rib angle, the normal displacement showed a tendency of decreasing first and then increasing. This is because shear expansion and slippage failure mainly occur at 15°, and there is no shear fracture failure, and the normal displacement is larger, and the phenomenon of raised shear-break failure occurs at 30°, and the normal displacement is smaller.

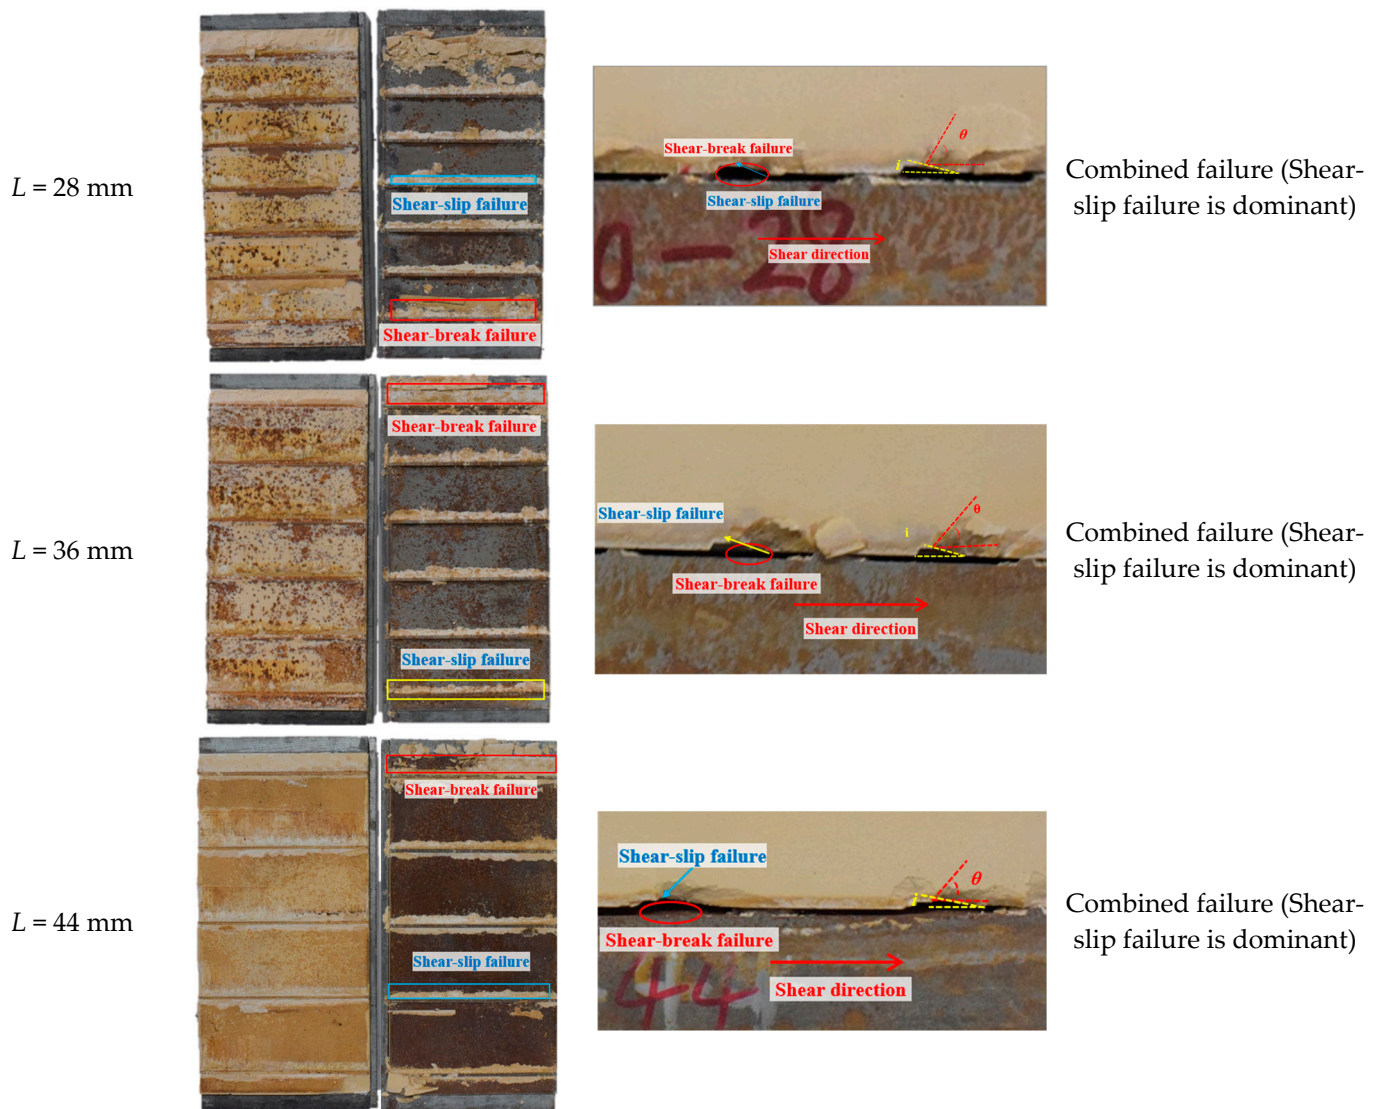
For ease of exploring the impact of varying rib spacings, we conducted specific analysis on the failure morphology of the interface under $\sigma_n = 2$ MPa for five different rib spacings, as illustrated in Figure 16. The angle θ indicates the inclination angle of the crack created along the upper right side of the gypsum specimen, and i indicates the angle between the shear break direction and the horizontal direction in the figure.

When L is 12 mm, i is about 17° (which finally produces a nearly horizontal macroscopic rupture band), and θ is about 25°. Most of the gaps between the ribs have been filled with worn or sheared gypsum debris, in which the narrower and lighter color debris band near the root of the ribs is debris generated by the shear-slip failure, while the wider and yellowish debris band between the two ribs is debris generated by the shear-break failure. There is a certain gap between the upper and lower specimens, and the gypsum near the ribs of the upper specimen is not all sheared, which indicates that shear-slip failure was generated. Therefore, the interface failure mode is a combined failure, but mainly shear-break failure.

Figure 16. The failure patterns of interfaces under different rib spacing.

When L is 20 mm, according to the side view, the upper and lower specimens are completely separated and partially sheared at the edge of the gypsum between the two ribs, where i is about 21° , and θ is about 43° . There is a certain gap between the upper and lower specimens, and the gypsum near the rib of the upper specimen is not completely sheared, which indicates that shear-break failure is generated, so the interface failure mode is a combined failure. From the top view, most of the gypsum debris is located near the root of the ribs and the debris zone is narrow. No obvious large-scale shear-break failure has occurred, so shear-slip failure accounts for a larger proportion of the combined failure.

When the rib spacing was 28 mm, 36 mm and 44 mm, respectively, the interface failure morphology was similar to that of the interface failure morphology when the rib spacing was 20 mm, the failure modes were all combined failures, and the shear-slip failures accounted for a larger proportion.

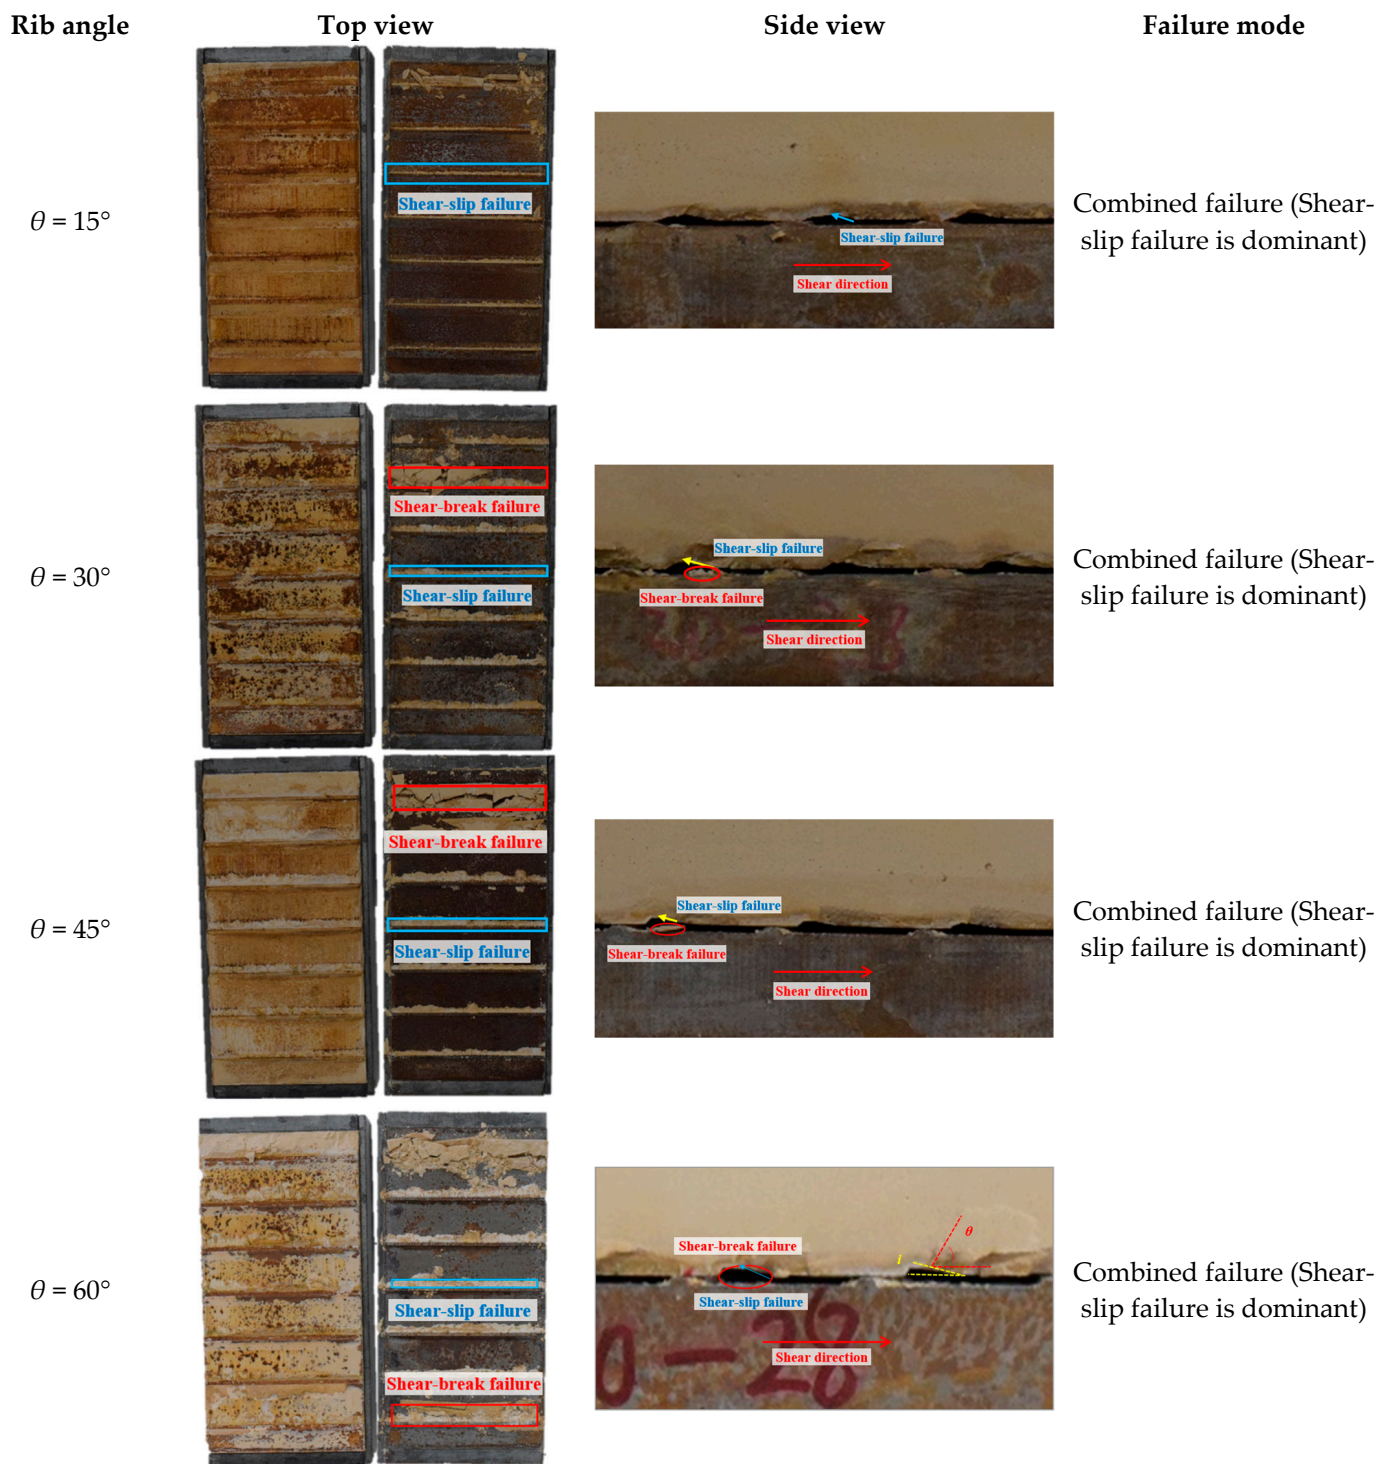
For ease of exploring the impact of varying rib angles on interface failure modes, we conducted a specific analysis on the failure morphology of the interface under normal stress $\sigma_n = 2$ MPa for five different rib spacings, as illustrated in Figure 17.

Figure 17. The failure patterns of interface under different rib angle.

When the rib surface angle $\theta = 15^\circ$, according to the top view, most of the gypsum debris is located near the root of the ribs. The failure is mostly abrasion failure occurring in climbing, and there is no obvious shear-break or compression-shear crushing, so the interface failure mode is mainly shear-slip failure. Because the rib angle is small at this time, the gypsum protrusion and the inclined surface of the rib are gentle, indicating that the interface roughness and undulation are small. With the increase in shear displacement, the gypsum protrusion is prone to climbing along the inclined surface of the rib, and in the process of climbing, the gypsum contact interface with the rib due to the restriction of the normal stresses. Part of the gypsum debris is left in the vicinity of the rib, which generates the shear-slip failure.

When the rib angle $\theta = 30^\circ$, according to the top view, most of the gypsum debris is located near the root of the ribs, and there are large pieces of debris and wider debris bands. The proportion of shear-break failure has increased, but the failure mode is still dominated by the shear-slip failure. This is because, as the rib angle increases, the gypsum bulge and the inclined surface of the ribs become steeper, indicating that the interface roughness and undulation increase, and with the increase in shear displacement, the difficulty of climbing increases. The climbing phenomenon is rarer in occurrence, and shearing occurs at the edge part of the bulge, making the percentage of shear-failure increase.

When the rib angle is 45° , 60° and 75° , the interface failure morphology is similar to that of the interface failure morphology when the rib angle is 30° . Also, the failure modes are all combined failure, and the shear-slip damages are dominant; however, due to the difference of the rib angle, the proportion of shear-break failure has changed.

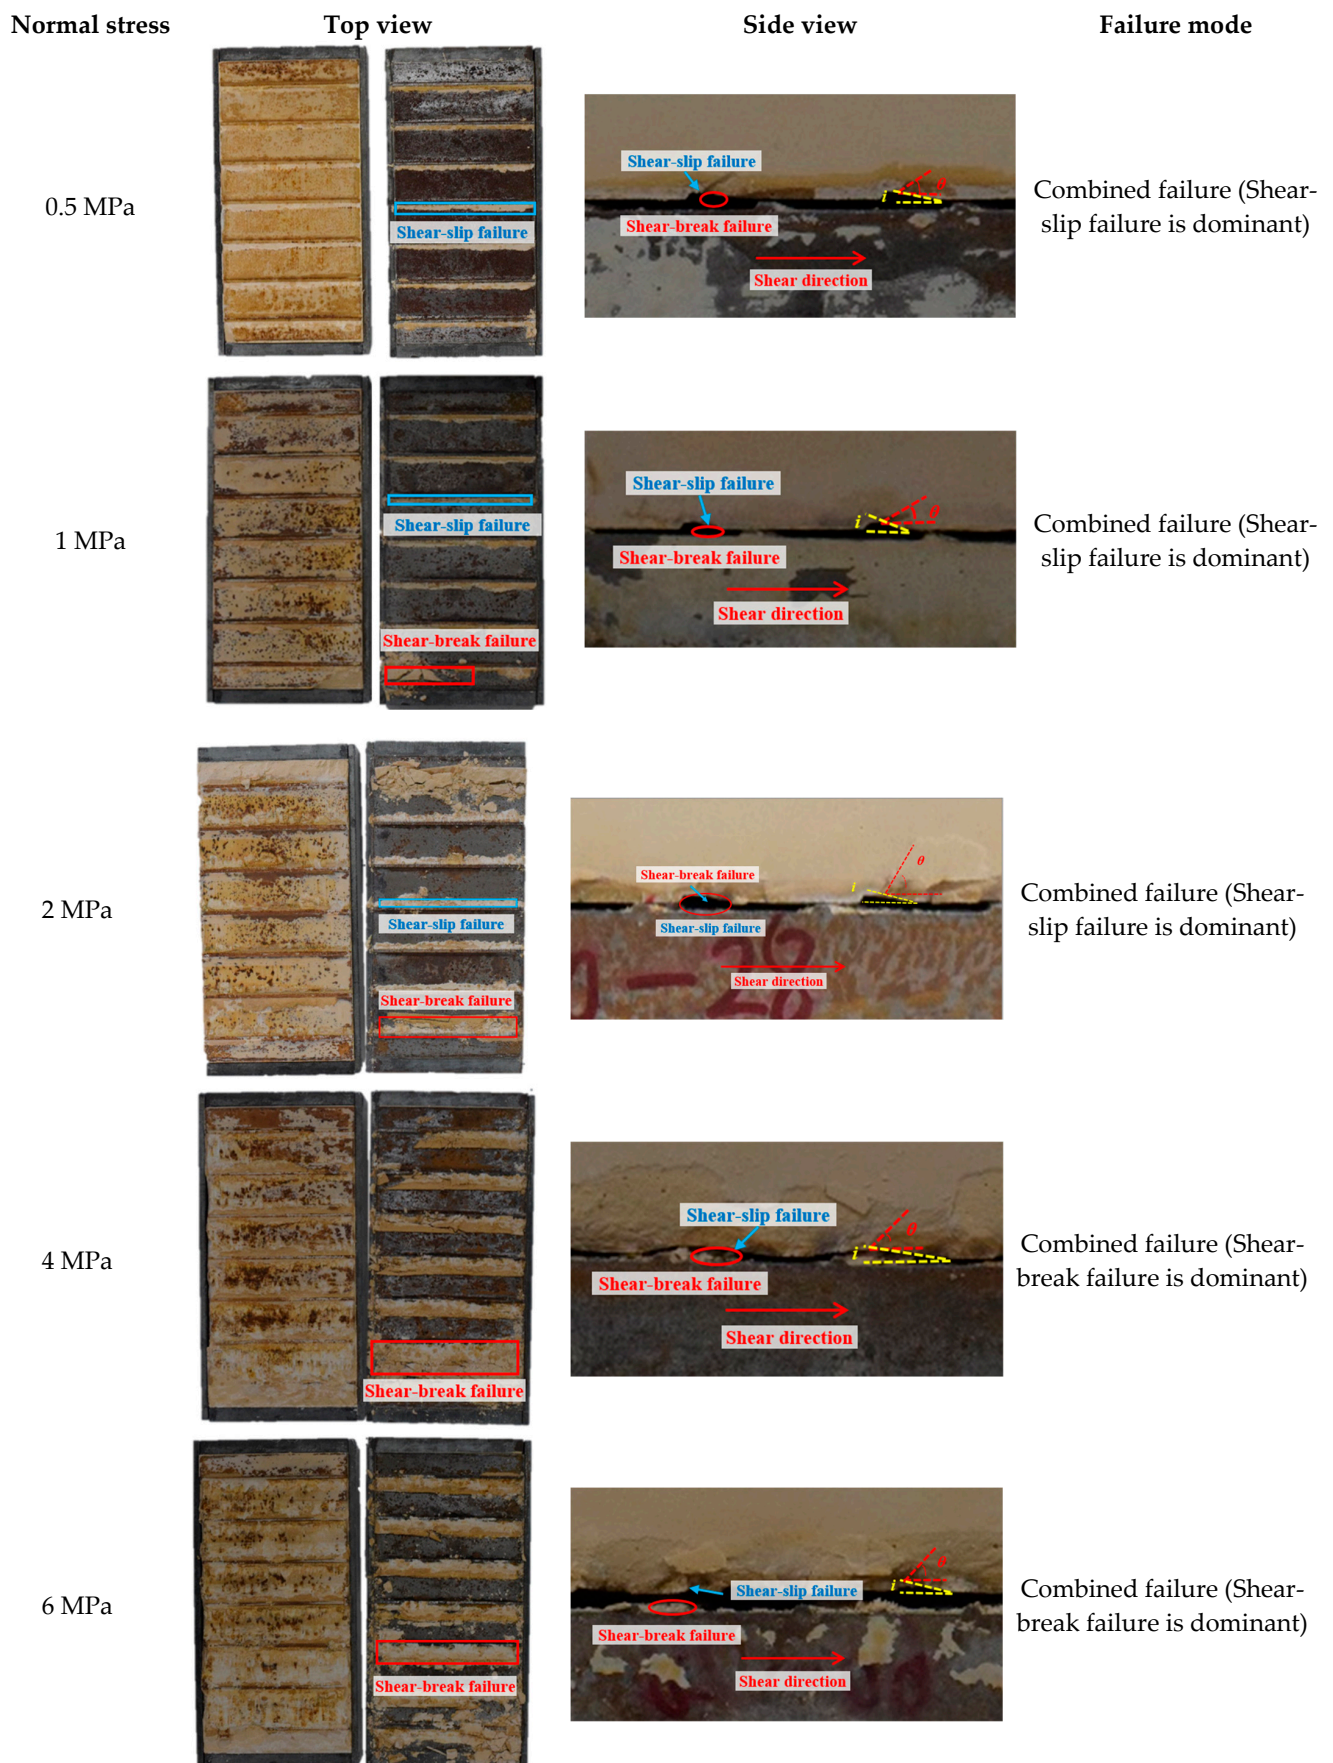
To study the impact of normal stress on the failure mode, the interface failure morphology pattern of five normal stresses under the conditions of 28 mm rib spacing and 60° rib angle were selected for analysis, as shown in Figure 18. When the normal stress is low, such as 0.5 MPa, the surface of the gypsum specimen produces many nearly parallel tilted failure surfaces, placing the gypsum specimen upward over the raised portion of the steel plate. There is only a small amount of gypsum debris at the ribs of the bolt specimen, and the debris zone is also narrower. This indicates that shear-slip failures are predominant, with a small number of shear-break failures as well. When the normal stress is 1 MPa and 2 MPa, the shear failure mode is a combined failure. The analysis shows that the share of shear-slip failure decreases and the share of shear-break failure increases with raise normal stress.

Figure 18. The failure patterns of interface under different normal stresses.
