International Journal of Environment and Climate Change

An Analytic Case Study of Lentic Ecosystem and Rejuvenation of Bellandur and Varthur Lakes in Bengaluru, India

Original Research Article

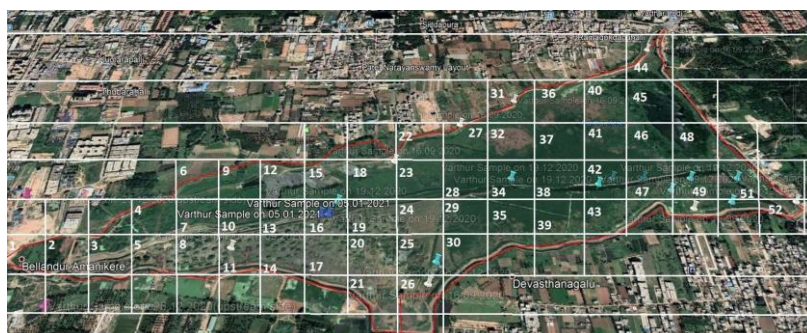
Fig. 2. Soil sampling locations taken on (25.12.2020) shown on Google map of Varthur lake

The lake is located in the eastern part of the city. It is the last lake in the K- C valley series and almost surrounded by builtup area (Fig. 2).

Soil samples analysis and recommendations for Varthur lake: Soil samples, at three different depths of two meters pits have been collected on 16.09.2020, 19.12.2020, and 05.01.2021 (Fig. 2). The soil samples were got analyzed from a CPCB-recognised laboratory in Chennai (India). About 20 parameters have been taken into consideration for sediment quality as per the guidelines document for the assessment and remediation of contaminated sites in India of MoEF&CC. The parameter considered for sediment quality are the same as in Bellandur. The sediment analysis results are based on the
