Article

Effectiveness of Nanotechnology Treatments in Composite Aircraft Applications

Abstract: This paper aims to verify the effectiveness of a process of superficial protection based on nanotechnologies produced by 4Ward360 and specifically developed for aeronautical applications on composite material aircraft. The Dardo aircraft, a composite VLA category manufactured by CFM Air, was taken as a reference case and two application/investigation areas were identified. The potential anticorrosive behavior of the nanotechnology treatment was investigated when applied to the metal joints of the aircraft, such as the wing–fuselage attachments usually made of Al-2024-T3 aluminum alloy. Furthermore, the potential increased effectiveness in cleaning was investigated as another possible application concerning the parts made of composite material both solid and in a sandwich configuration and the plexiglass parts of the canopy.

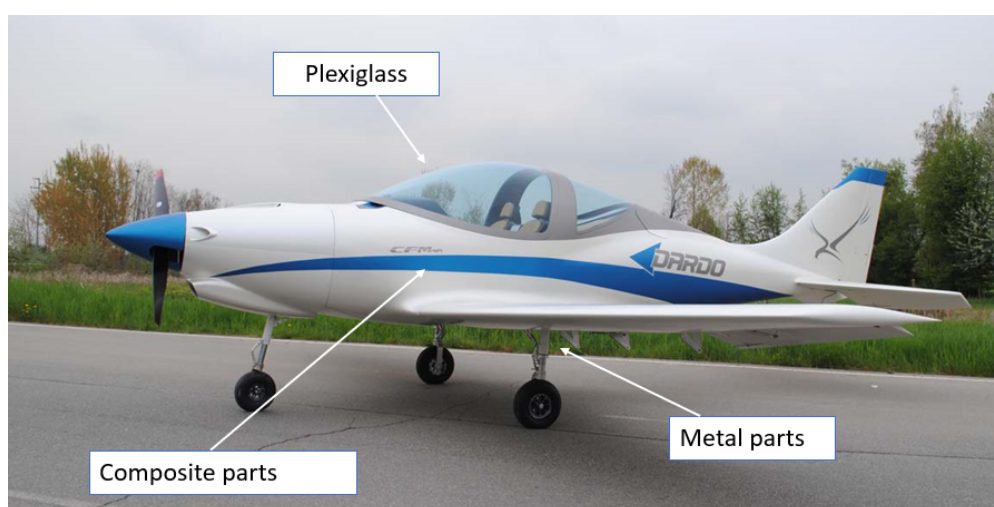
The Dardo aircraft (Figure 1) is a light aircraft designed to operate from short fields as are typically found in logistically austere environments. It is able to operate up to a service ceiling of 12,000 ft, and never exceeds a speed of 170 KCAS. It must also carry a max fuel content of 80 Kg that allows for an endurance of 4 h. The nominal range is in the order of 350 NM.

Figure 1. Dardo aircraft.

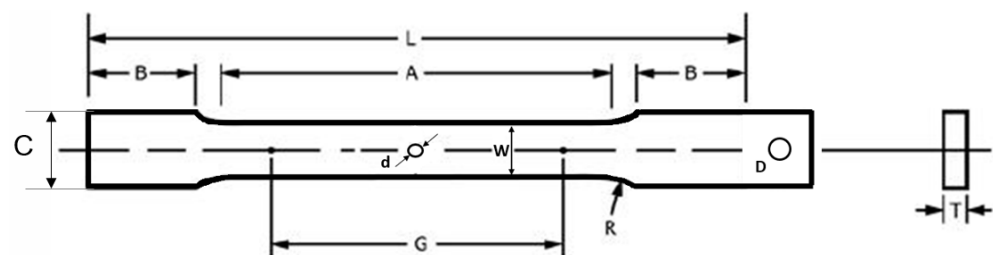
The dimensions of each specimen can be deduced from Figure 2 and Table 1. The standard specimens were modified by introducing two holes, a central one of 2 mm necessary to increase the stress intensity factor and therefore limit the duration of the next fatigue test. A second hole of 5 mm was present at one end to allow immersion in the corrosion tank.

Figure 2. Specimen's geometry definition.

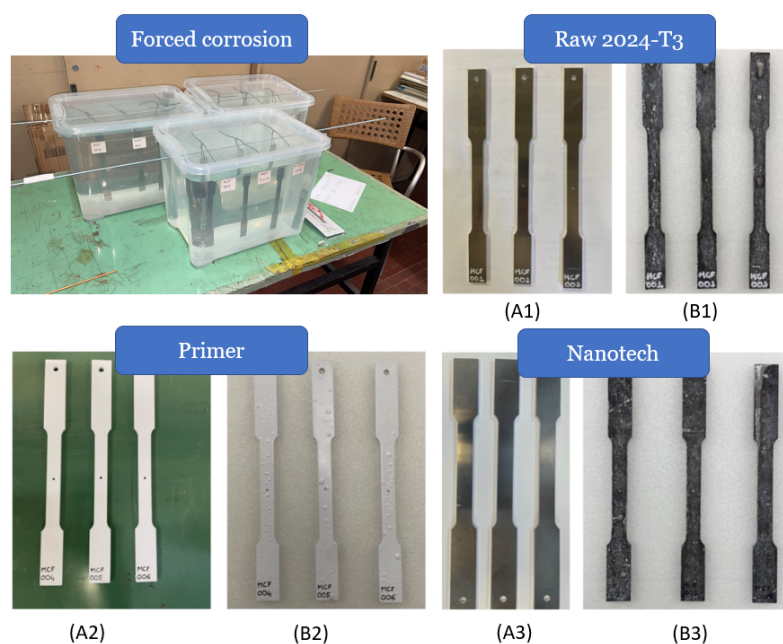
In image (A) of Figure 3, it is possible to observe the aluminum specimens marked with the identification code, before immersion in the bath and in (B) immediately after the phase of extraction from the corrosive bath. A loss of luster was noted for the raw aluminum specimens, a darker coloring and the presence of numerous encrustations of salt as well as a lower smoothness to the touch. A loss of luster was noted for the Al-primer together with surface bubble formation as previously mentioned. Finally, for the specimens treated with nanotechnologies, a loss of luster of the metal and a darker coloration were noted but with less formation of salt encrustations. Also in that case, a reduction in smoothness was found.

Figure 3. Specimens: (A1–A3) before corrosion; (B1–B3) after corrosion. “Raw 2024-T3”: aluminum without corrosion protection; “Primer”: aluminum treated with a standard primer; “Nanotech”: aluminum treated with nanotechnology.

In the three tanks, it was possible to observe some important characteristics: all three tanks showed an accumulation of sodium chloride at the bottom in correspondence to each sample, as if each one had attracted the salt to itself, which had no way of adhering completely to the metal surface, precipitating into the solution. It should be noted that the solute accumulations were more consistent in the untreated raw aluminum specimens and in the nanotechnology-treated ones, while on those treated with the primer, there were no traces of salt evidence, but they could already show bubbles of the surface treatment.

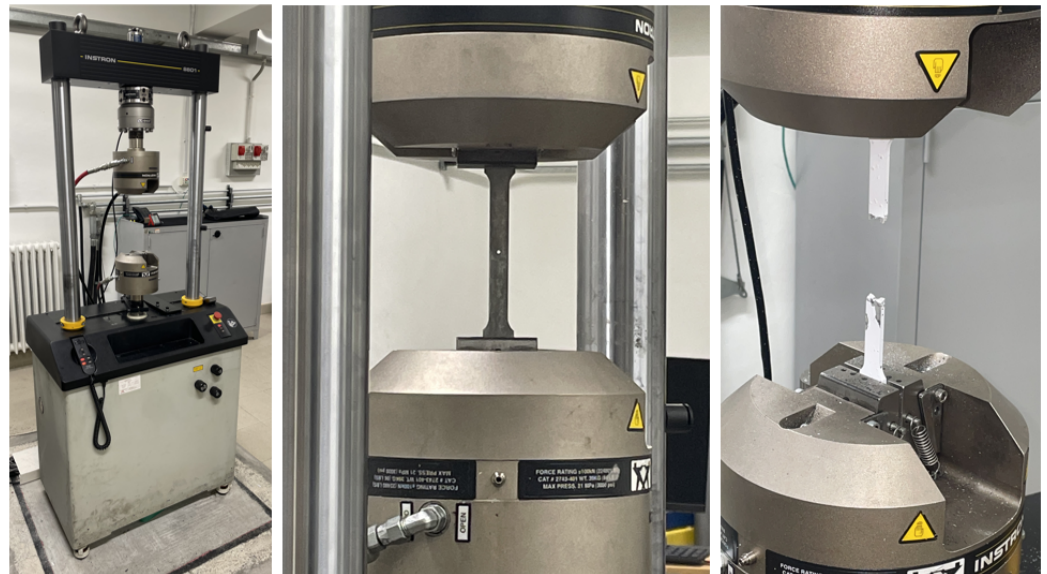
The INSTRON 8801 machine (Figure 4), available at Politecnico di Torino-DIMEAS structural laboratories, was used to carry out the fatigue tests. In addition to the 9 specimens subjected to corrosive treatment, the other 4 specimens were added, bringing the total of those mechanically tested to 13 in order to have a direct comparison between the same types of surface coatings with the only discriminating factor being the corrosive process undergone. All the samples reported in Table 2 were subjected to the fatigue test, highlighting those that underwent the corrosive process. Table 2 also shows the three selected load levels, the maximum and minimum force of the applied cycle, and the frequency of load application. The need to conduct fatigue tests, operating with three different load levels, arises from the need, albeit with the limitation of the reduced number of specimens, to approach the definition of the S-N curves [10,16].

Figure 4. Specimen installed in the fatigue test machine.

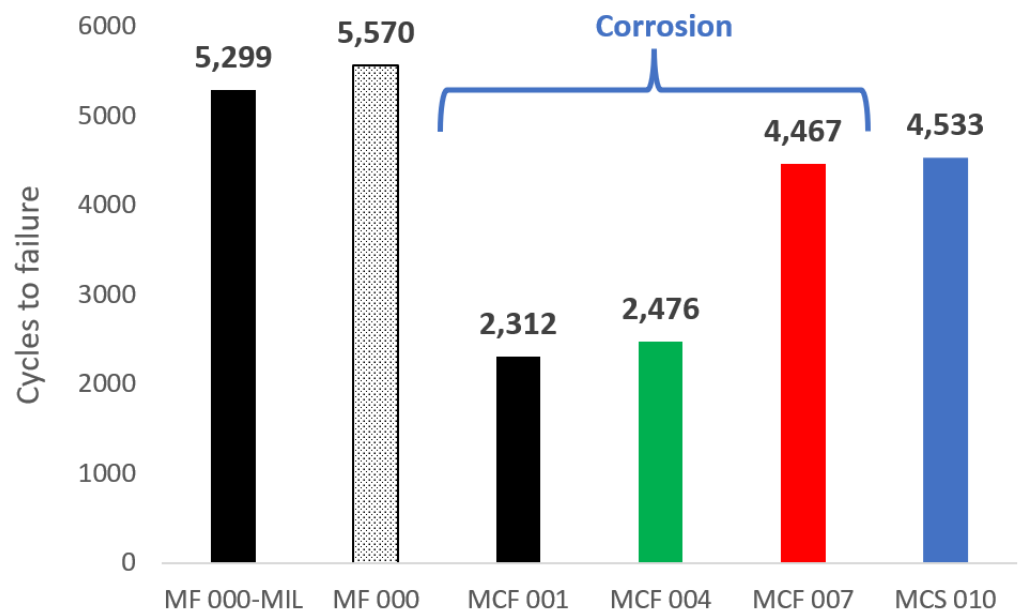
Figure 5 presents the number of cycles to failure of the specimens subjected to load type 1 corresponding to $F_{max} = 11$ kN, $F_{min} = 0$ kN, and a frequency of $f = 5$ Hz. The specimens subjected to corrosion are also indicated. For this load, we note a significant reduction in fatigue life for the untreated MCF001 specimen and also for the Al-Primer specimen (MCF04) compared to the uncorroded case MF000, demonstrating the evident reduction in fatigue life due to the corrosion effect. The specimen treated with nanotechnologies (MCF007) in this case had a very similar behavior to that of the specimen of the same category not subjected to the corrosion process (MCS10), demonstrating an increased protective property against corrosion with an increase in fatigue life of +48% compared to raw Al, of +44% with respect to Al-Primer, and a small reduction of -1.44% when considering the uncorroded Nanotech specimen.

Figure 5. Load type 1: $F_{max} = 11, \text{ kN}$ $F_{min} = 0, \text{ and kN}$ $f = 5 \text{ Hz}$.

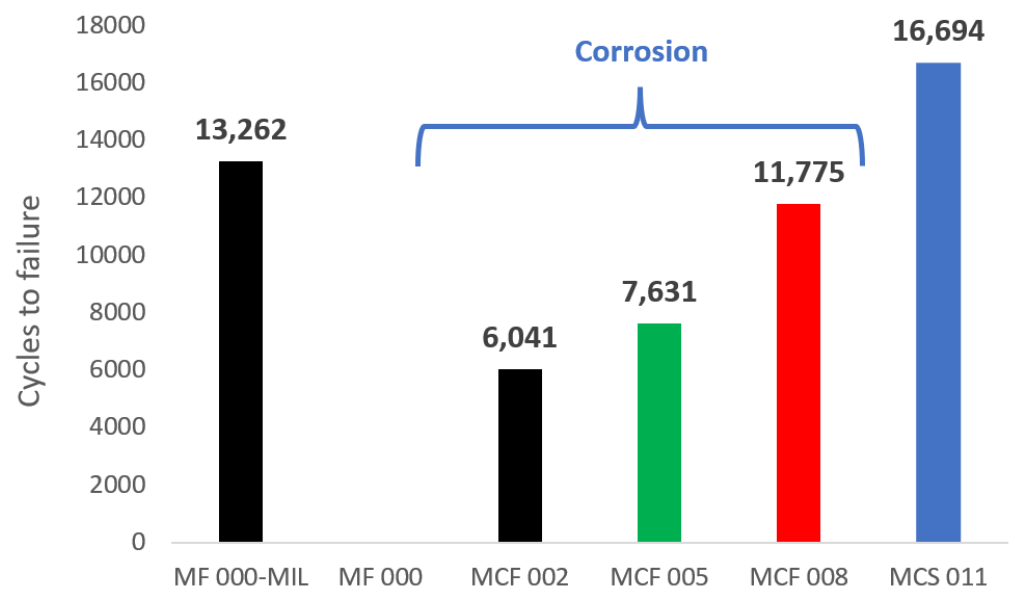
The results relating to the intermediate load level indicated with type 2 and corresponding to $F_{max} = 9$ kN, $F_{min} = 0$ N, and a frequency of $f = 5$ Hz are shown in Figure 6. Also in this case, an excellent behavior of the specimens treated with nanotechnologies and subjected to the corrosion process can be noted. In particular, the MCF008 specimen had an increase in life of +48% compared to raw aluminum (MCF002), +35% compared to the specimen treated with primer (MCF05), and a reduction of -29% compared to the specimen treated with nanotechnology but not corroded (MCS11). Finally, considering the lowest load level indicated in Figure 7 with type 3 and corresponding to a cycle defined by $F_{max} = 6$ kN, $F_{min} = 0$ N, and a frequency of $f = 5$ Hz, we still noticed a better behavior of the specimen treated with nanotechnologies albeit reduced compared to the previous case. In this case the MCF009 specimen had an increased fatigue life compared to raw aluminum (MCF003) of +39%, while compared to the primer (MCF006), the life increase was 33%, and the reduction compared to the uncorroded case (MCS012) increased to -66% .

Figure 6. Load type 2: $F_{max} = 9 \text{ kN}$, $F_{min} = 0 \text{ kN}$, and $f = 5 \text{ Hz}$.

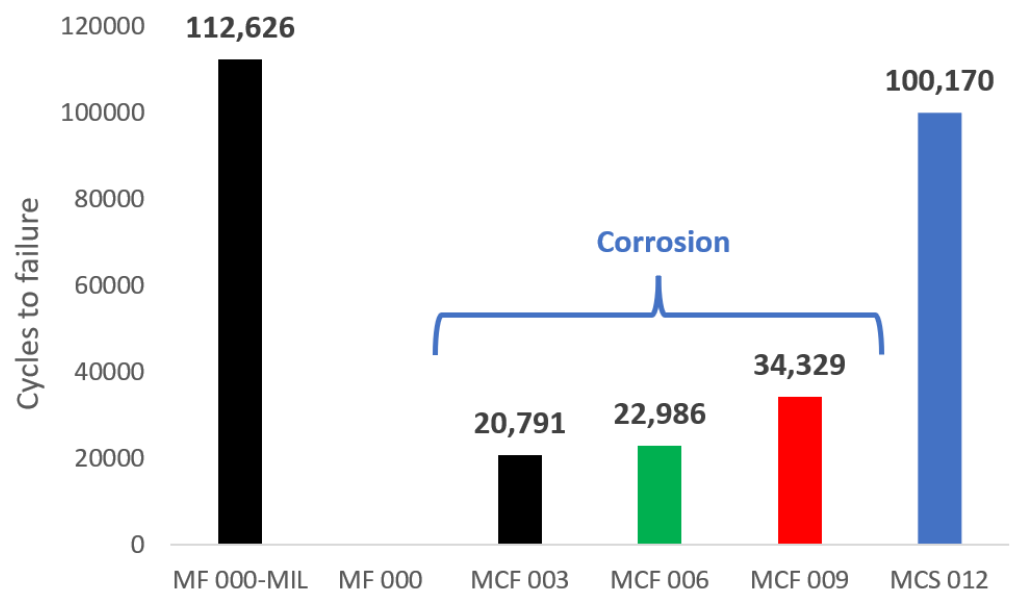
Figure 7. Load type 3: $F_{max} = 6$ kN, $F_{min} = 0$ kN, $f = 5$ Hz.

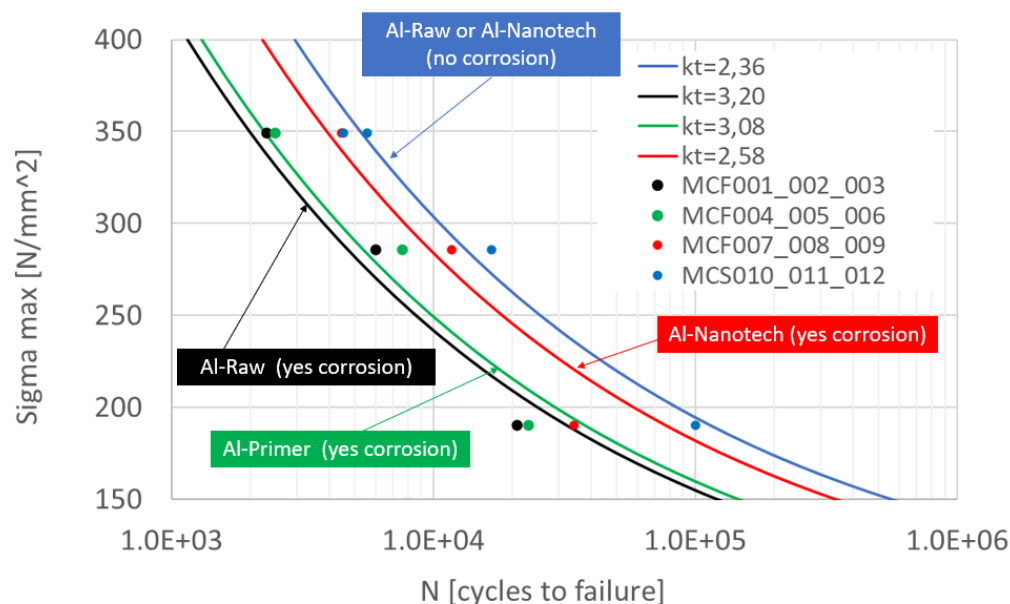
Figure 8 shows the S-N curves considered for the different cases discussed. In blue are the specimens not subject to corrosion, in black are the corroded and unprotected specimens, in green are the specimens protected with primer, and finally, in red are the specimens protected with nanotechnologies and subjected to the corrosion test. In all specimens subjected to corrosive immersion, a greater effect of corrosion was observed at lower loads (load types 2 and 3), confirming not only an increase in the stress concentration factor (kt) but also a change in the slope, as indicated also in [9].

Figure 8. S-N curve: blue: no corrosion; black: corroded specimens; green: primer protection; red: nanotechnology protection.

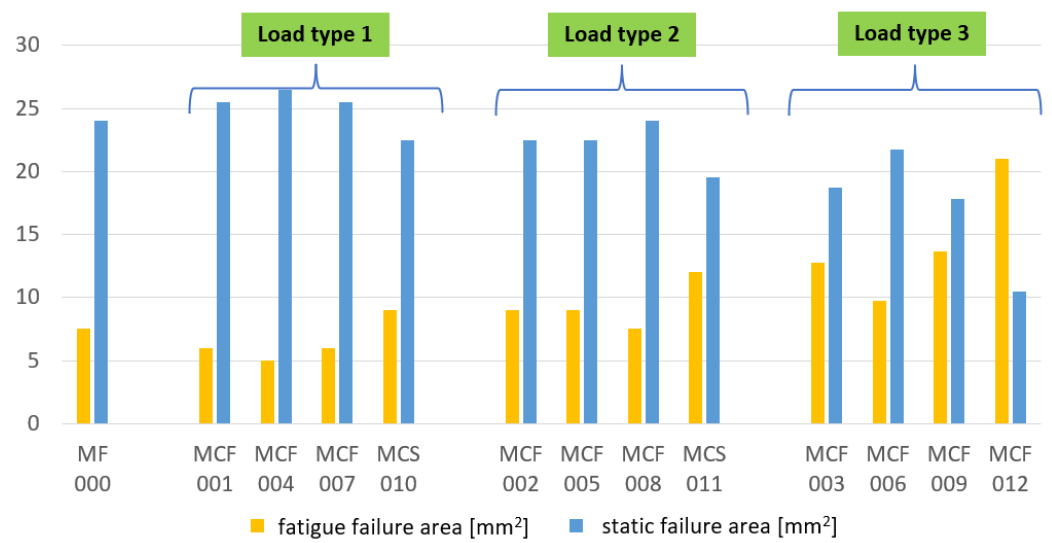
From Figure 9, where the results are divided by specimen category, it is possible to observe that, as could be expected, the extent of the fatigue failure section was more significant when the specimen under consideration was subjected to a lower stress: a lower mechanical load means a higher number of cycles, therefore a greater failure area due to fatigue. The graph also highlights what has already been observed previously: in each group of specimens, the best resistance to mechanical stress was always obtained with nanotechnology coating protection.

Figure 9. Comparison of failure areas for each type of load.

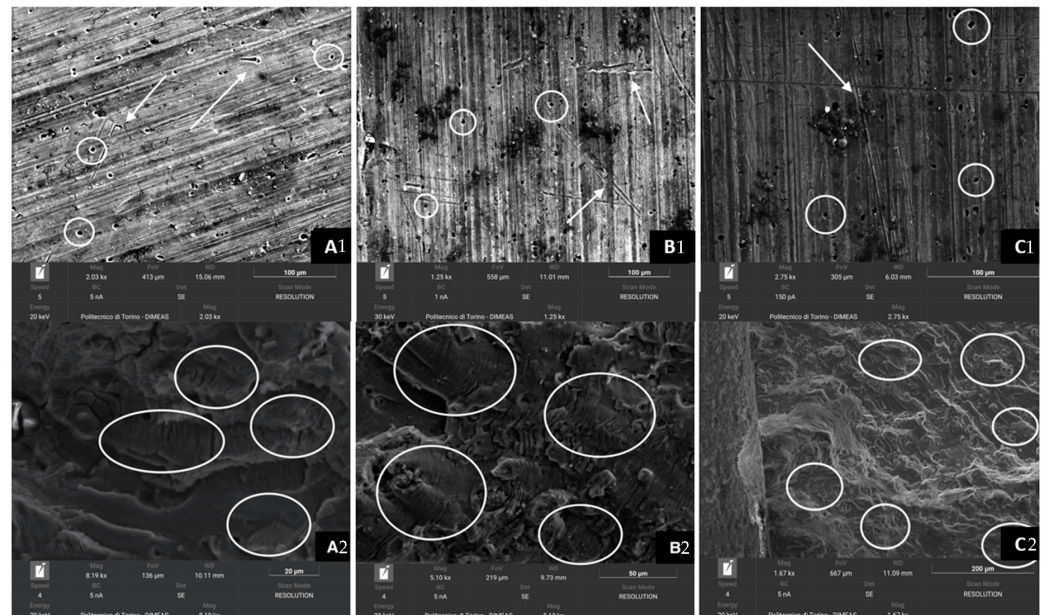
From the electron microscope (SEM) analysis, as reported in Figure 10, production damage (scratches and streaks) could be seen on all specimens subjected to corrosion as well as signs of surface pitting [19]; however, they were more consistent in size and number in the case of raw aluminum and primer treatment, where a detachment from the metal surface was observed. Pitting corrosion also occurred in the case of aluminum treated with nanotechnologies, but with characteristics at first sight decidedly more limited than what occurred in the other two cases.

Figure 10. SEM analysis: (A1,A2) MCF002; (B1,B2) MCF005; (C1,C2) MCF008.

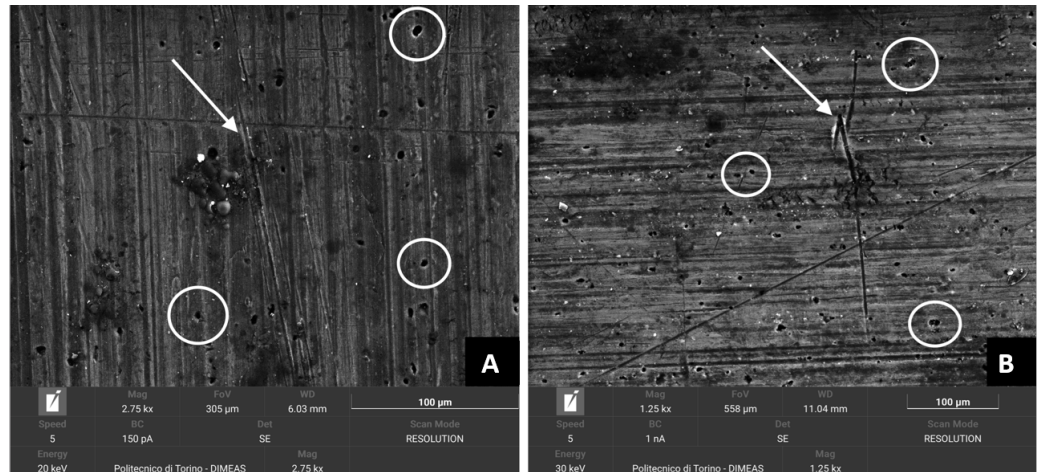
Considering the limited number of specimens considered in this study and observing Figure 11, it can be cautiously stated that at the same magnification, the corroded specimen, MCF 008, had the same number of holes and imperfections as the uncorroded one, MCS 012, both treated with nanotechnology, and only increased in size. The raw aluminum samples showed notable differences: an increase in the number of imperfections in the corroded sample, MCF 002, compared to its uncorroded counterpart, MF 000. This aspect shows a general improvement in the ability to resist corrosion for the nanotechnology-treated specimens.

Figure 11. Specimen surfaces MCF 008 (A) and specimen MCF 012 (B).

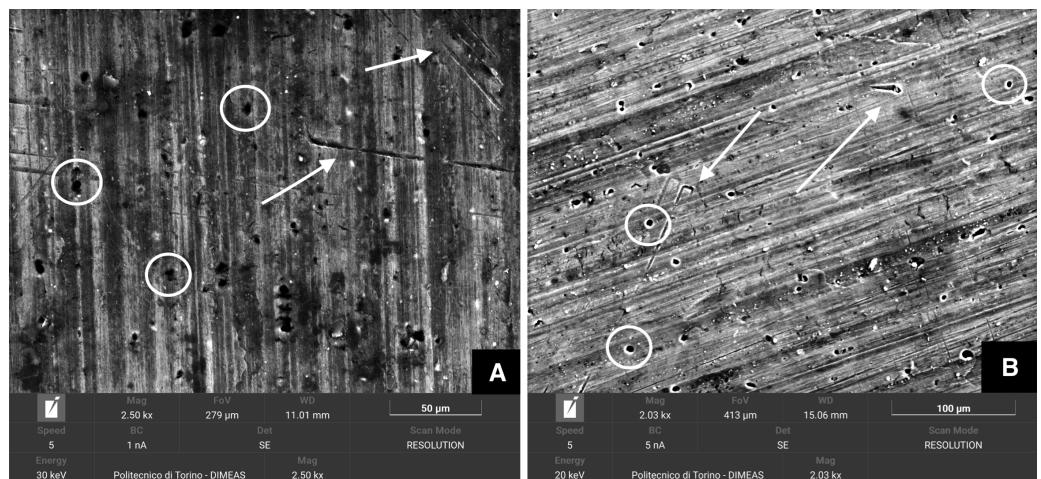
The analysis conducted by an SEM microscope provided better evidence of how corrosion affected the surface finish of the metal: to observe the same type of damage related to the machining and fabrication of the metal specimens, the corroded raw aluminum specimen, MCF 002, was analyzed at a lower magnification, compared to the uncorroded raw aluminum specimen, MF 000, see Figure 12.

Figure 12. Specimen surfaces MF 000 (A) and specimen MCF 002 (B).

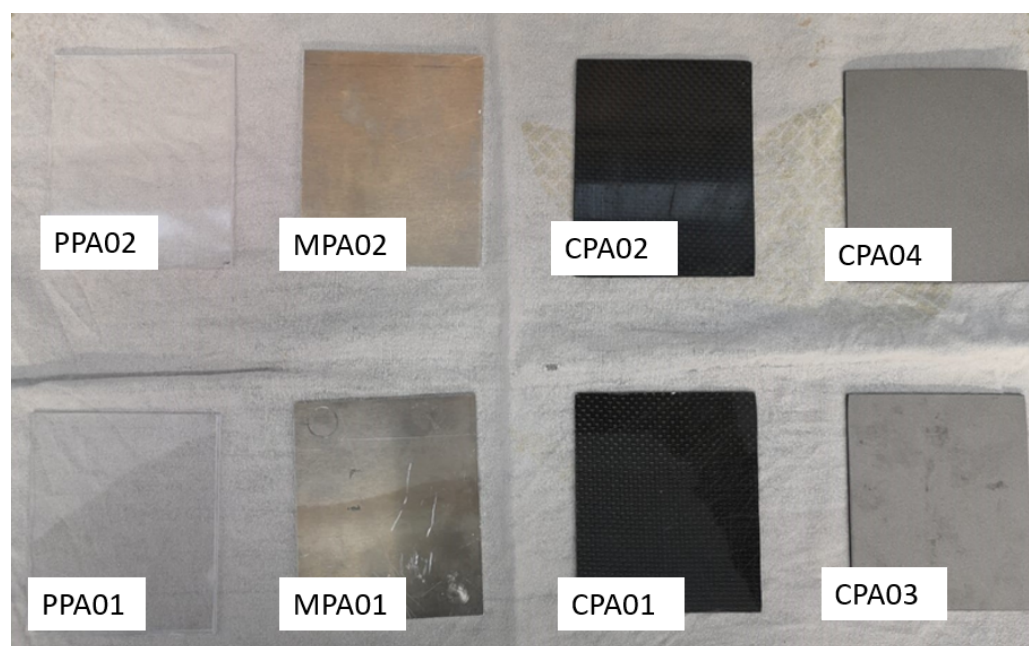
Table 4 and Figure 13 show the specimens subjected to cleaning tests.

Figure 13. Specimens under cleaning tests, see Table 4 for label definitions.

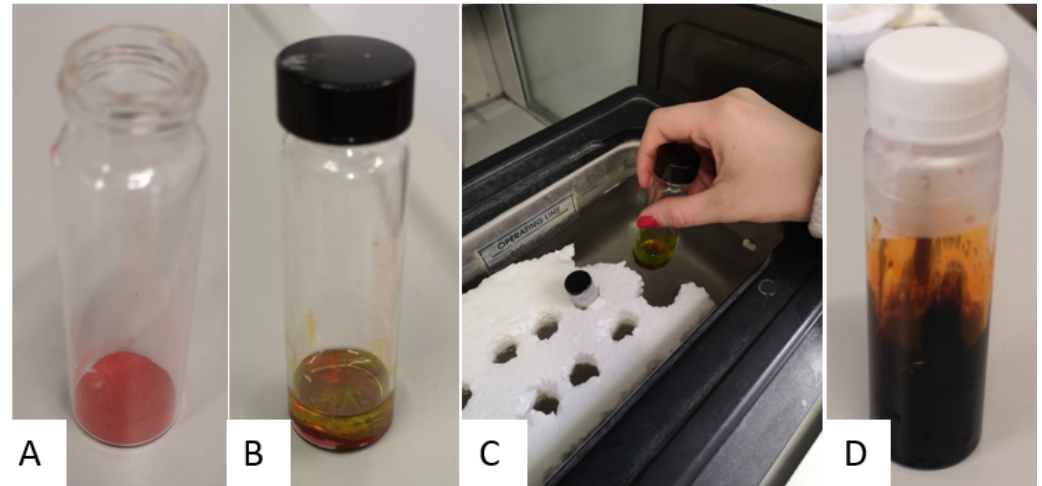
The fouling agent was a mixture consisting of 98% polyethylene glycol (PEG 400), 1% black dye, and 1% sodium fluorescein (Figure 14A). Sodium fluorescein was combined

with polyethylene glycol inside a small container (Figure 14B) and the mixture was made homogeneous by means of an ultrasound sonicator alternating mixing periods with stop periods (Figure 14C). Last, the black dye was added. The mixture thus produced had to be stored in the sealed container for at least one night before use (Figure 14D).

Figure 14. Foulant solution preparation: (A) sodium fluorescein (B) mixture of 1% sodium fluorescein and 98% of PEG400 (C) ultrasound sonicator (D) final mixture with addition of 1% black dye .

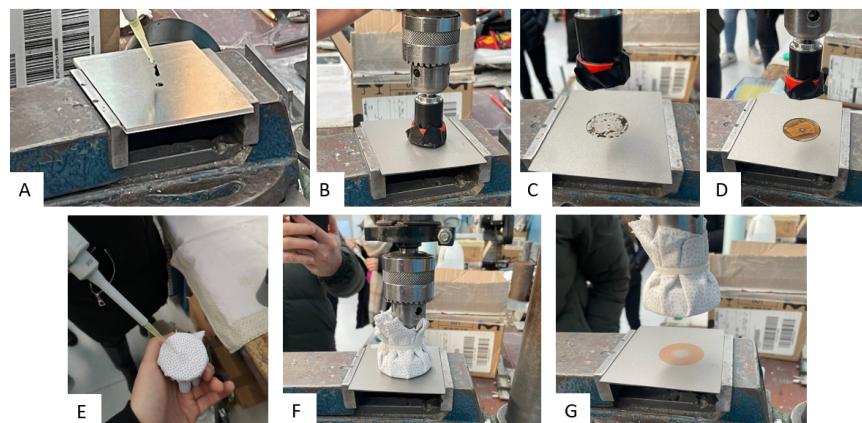
The application of the foulant agent started by positioning the specimens to be treated on the work table and filling the tip of the 0.025 mL repeating pipette with the foulant solution. A series of drops were dropped until an 80 μ L drop was deposited approximately in the center of each specimen.

The dirt head consisted of a 30 mm diameter polishing head with a Teflon adhesive tape glued to the relative surface to make it impermeable to the foulant agent. The cleaning head consisted of a 50 mm polishing head covered with four layers of cotton fabric, previously left for one night in a desiccator loaded with a saturated solution of potassium carbonate, with a humidity level of approximately 45%. The specimen had to be arranged in such a way that the foulant head rested exactly by gravity above the drop of dirt. The spindle was then started and left to act for one minute. Finally, the covered cleaning head was used after the cleaning tissue had been moistened in the center with 0.025 mL of water. The cleaning head was left to work for 22 s. At the end of the procedure, the cleaning head was removed without friction.

Figure 15. Dirtying procedure (A–D) and cleaning procedure (E–G).

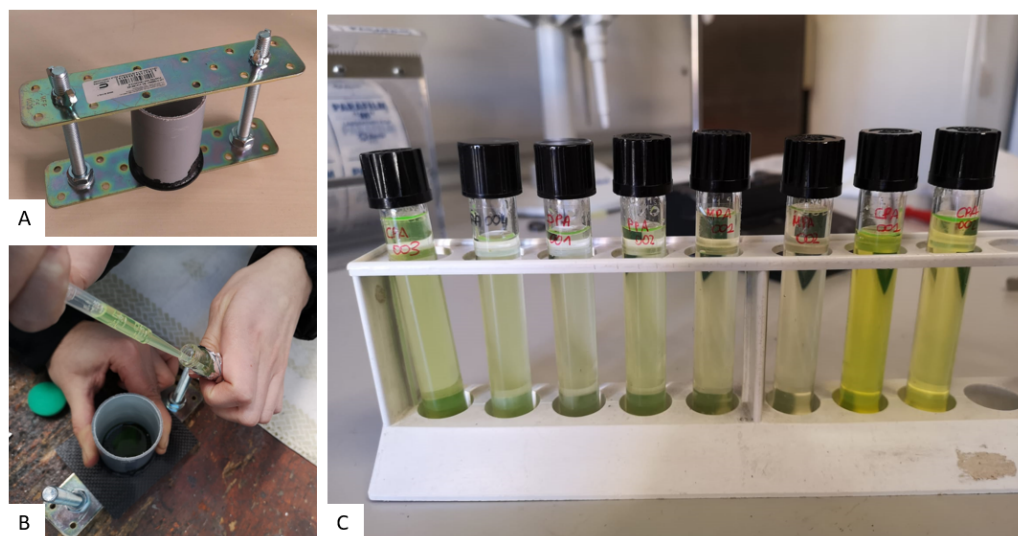
The procedure for removing the residual dirt, often barely visible, from the central portion of the specimen on which the foulant/cleaning procedure was carried out was then started. To do this, 10 mL of distilled water was introduced into the extraction device within 30 min of the foulant procedure, respecting some indications given by the regulation. The first specimen was placed face up within the clamp frame of the extraction fixture. The sealed tube was then placed in the center of the specimen, so that the seal defined the solution extraction area. Once the tube had been locked in the frame with a slight pressure generated by the screwing of the wing nuts, 10 mL of distilled water was added, stirred, and left to rest for 3 min. Finally, with a Pasteur pipette, a portion of the solution obtained was inserted into the test tube, correctly labeled, and placed on the rack, while the subsequent samples were extracted.

Figure 16. Extraction of residual dirt: (A,B) extraction fixture; (C) test rack with solution samples.

With the same amount of time to carry out the cleaning procedure, it can be noted that the Al2024 sample treated with nanotechnologies had a 16% increase in dirt removed, and the raw carbon treated with nanotechnologies had a 7% increase in dirt removed. The painted carbon treated with nanotechnologies had a 15% increase in dirt removed. Finally, the plexiglass treated with nanotechnologies had a decrease in dirt eliminated of 23%. Despite the apparently negative result obtained on the plexiglass, the results obtained on the composite and on the metal are promising in terms of efficacy of nanotechnology in terms of cleaning improvement. Likely, the ability of surfaces treated with nanotechnologies to be easier to clean (at least for CFC and Al2024) is due to the hydrophobicity characteristic that silicon nanoparticles are capable of attributing to the substrate on which they are applied. This property is also observable in Figure 15 where a visual comparison is made on the distribution of dirt in one treated and one untreated specimen. Extraction of the residual dirt and solution samples preparation is shown in Figure 16.
